Photographs – Exhibit TJFA 424

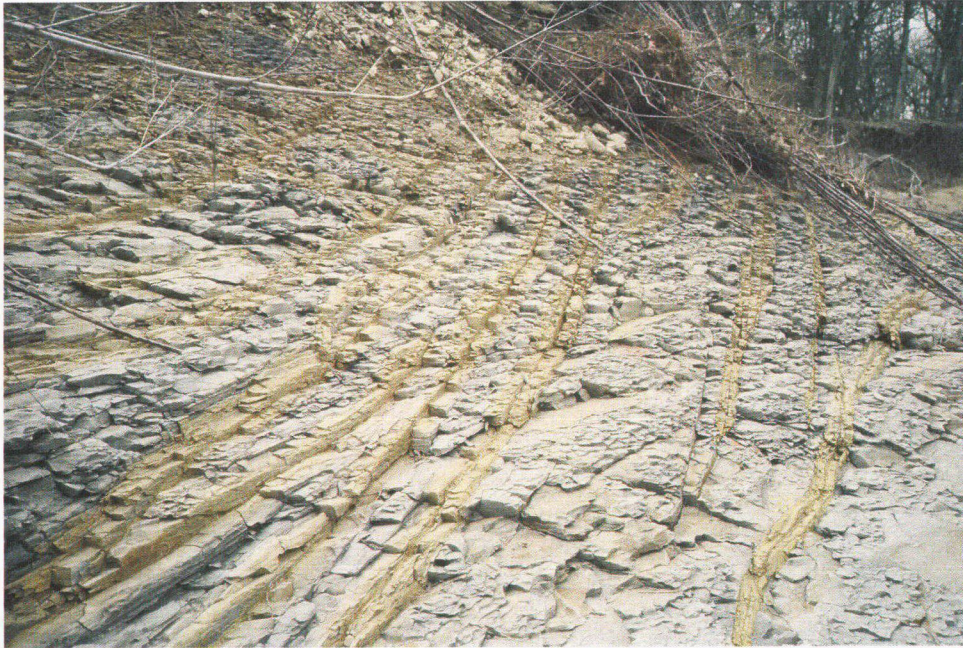
Exhibit TJFA 424-A, Joint Set in Weathered Taylor Marl – Skyline MSW Landfill

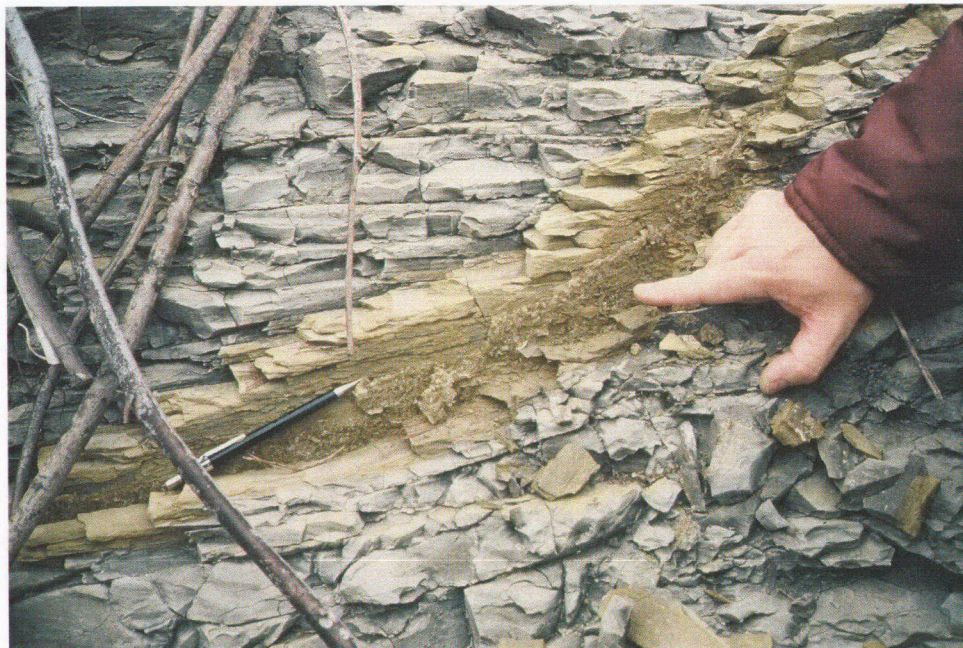
Exhibit TJFA 424-B, Mineralization in Joint in Weathered Taylor Marl – Skyline MSW Landfill

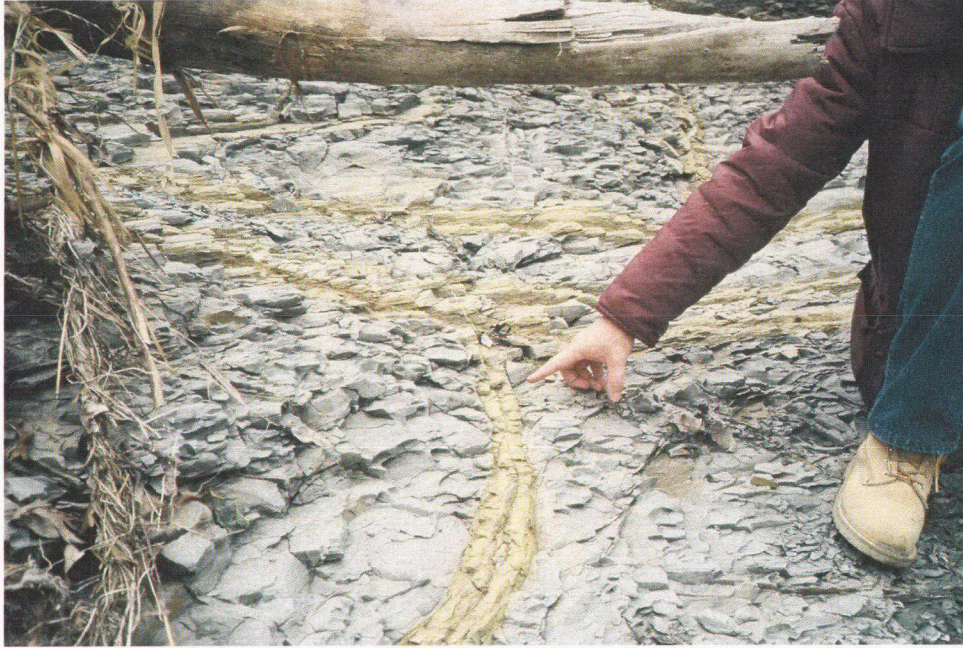
Exhibit TJFA 424-C, Intersecting Joints in Weathered Taylor Marl – Skyline MSW Landfill

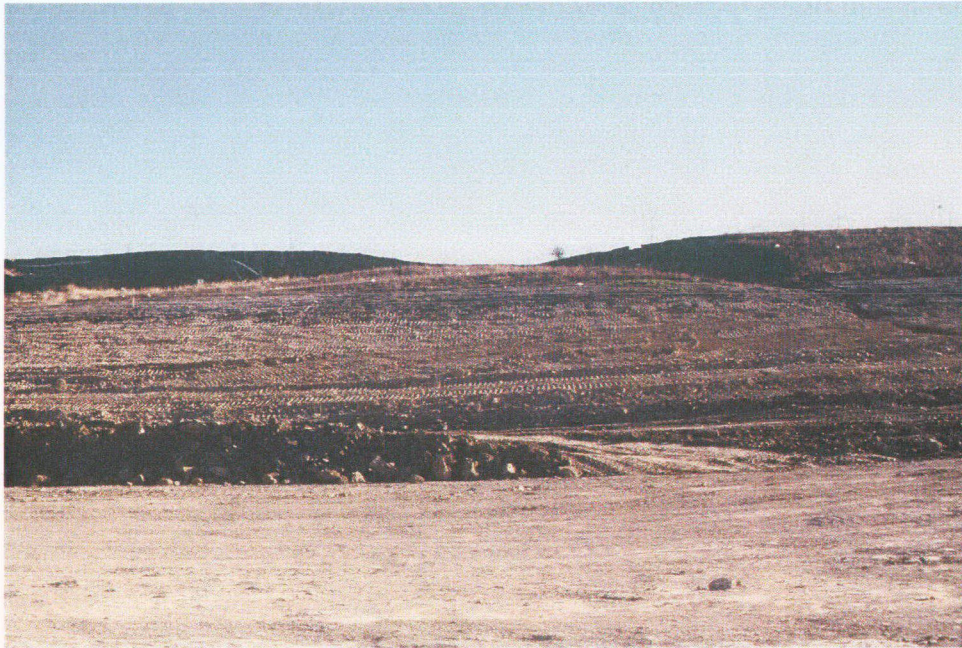
Exhibit TJFA 424-D, Excavation Slope Failure – Skyline MSW Landfill, 1999

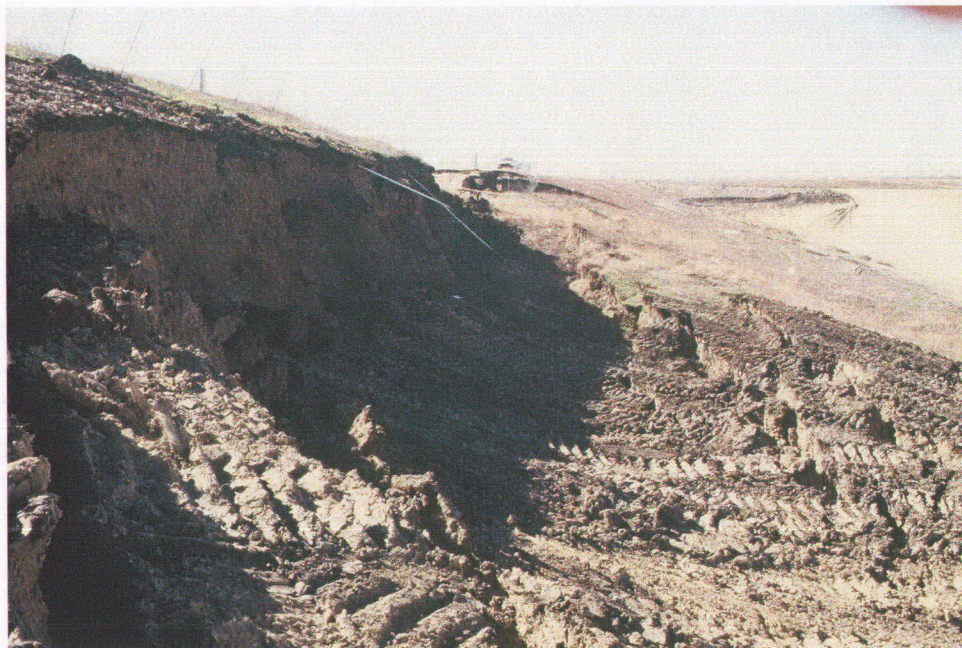
Exhibit TJFA 424-E, Excavation Slope Failure – Skyline MSW Landfill, 1999

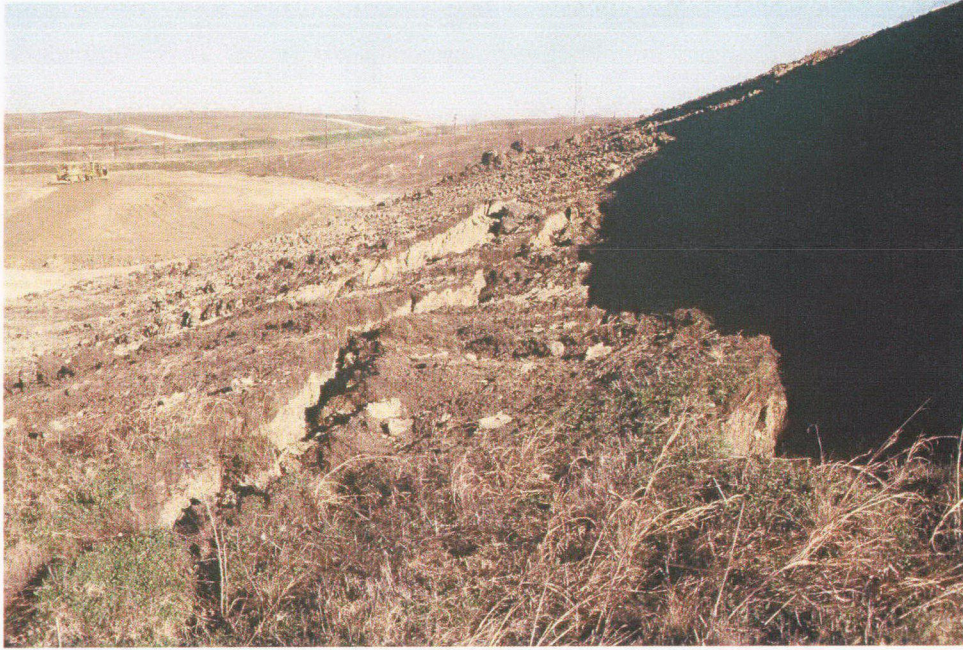
Exhibit TJFA 424-F, Excavation Slope Failure – Skyline MSW Landfill, 1999

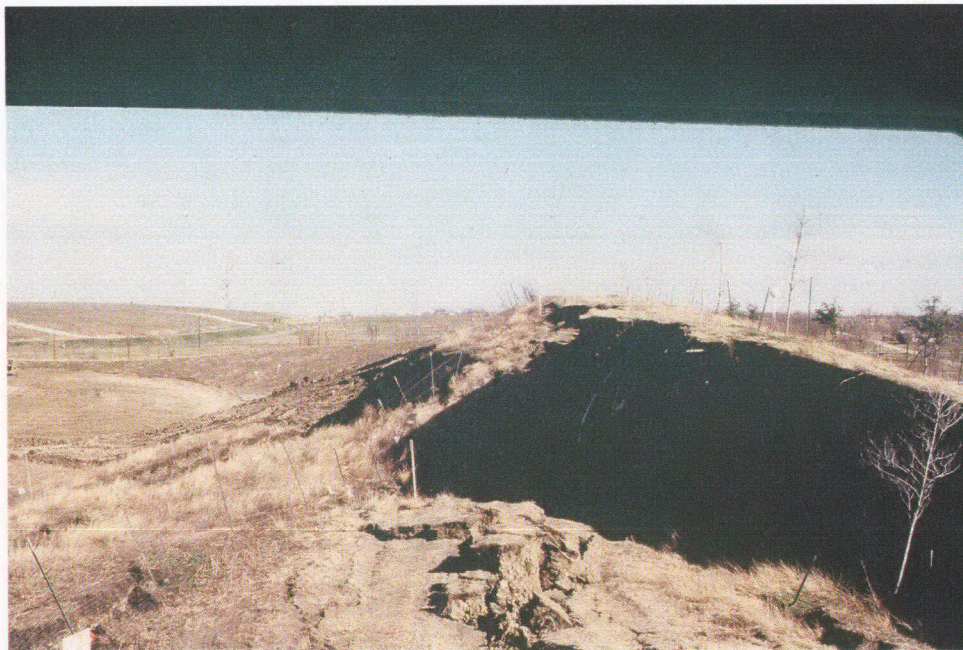
Exhibit TJFA 424-G, Excavation Slope Failure – Skyline MSW Landfill, 1999

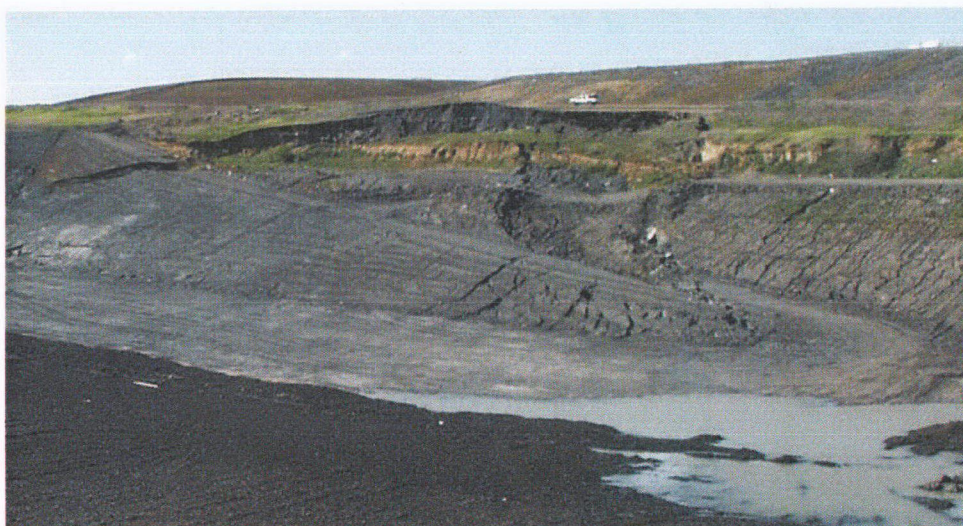
Exhibit TJFA 424-H, Excavation Slope Failure – City of Irving MSW Landfill, 1999

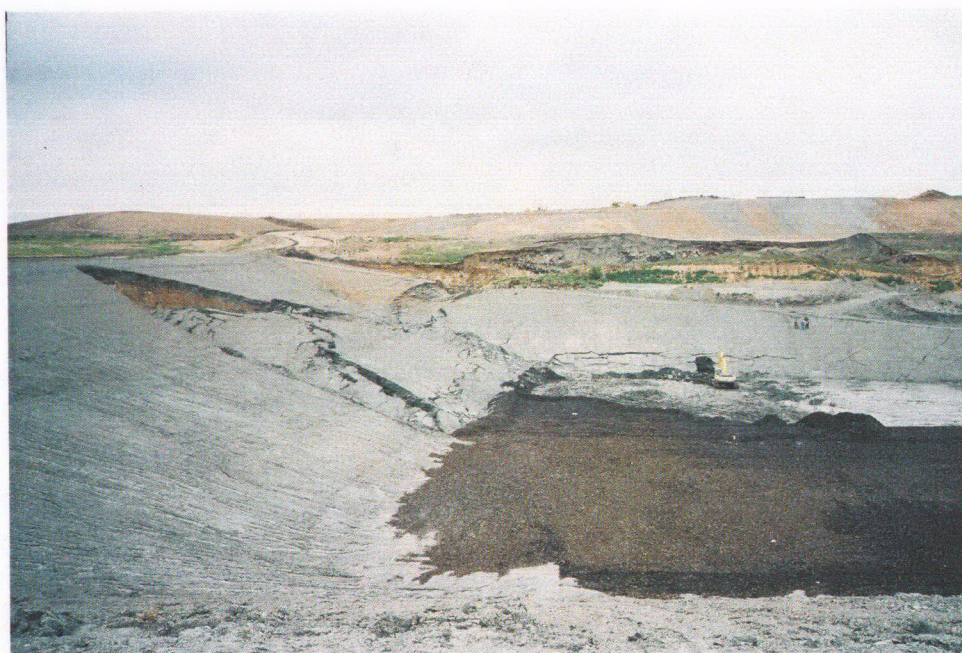
Exhibit TJFA 424-I, Excavation Slope Failure – City of Irving MSW Landfill, 1999

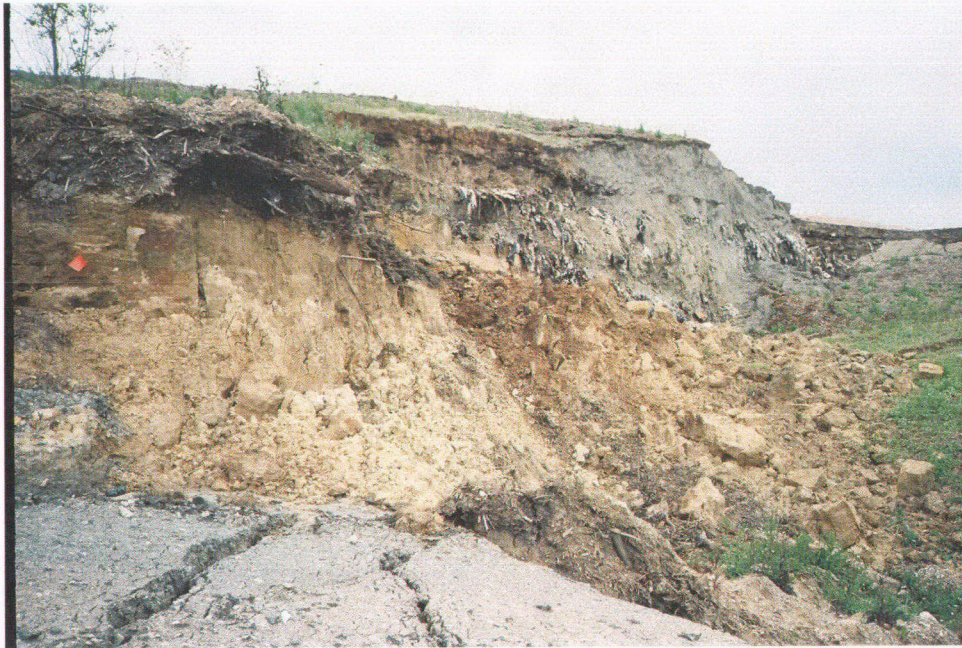
Exhibit TJFA 424-J, Excavation Slope Failure – City of Irving MSW Landfill, 1999

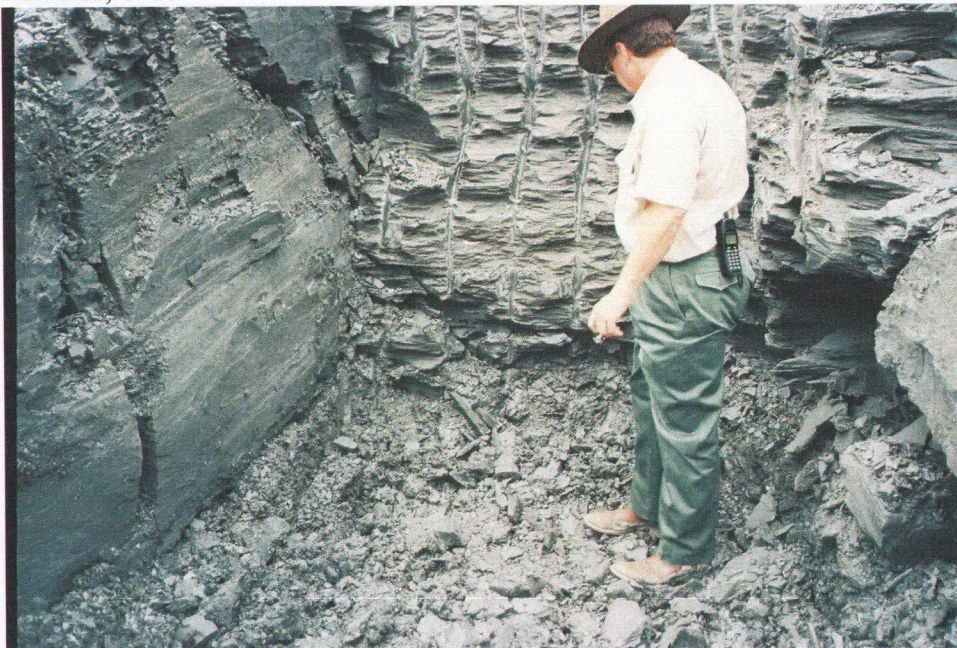
Exhibit TJFA 424-K, Excavation Slope Failure – City of Irving MSW Landfill, 1999
