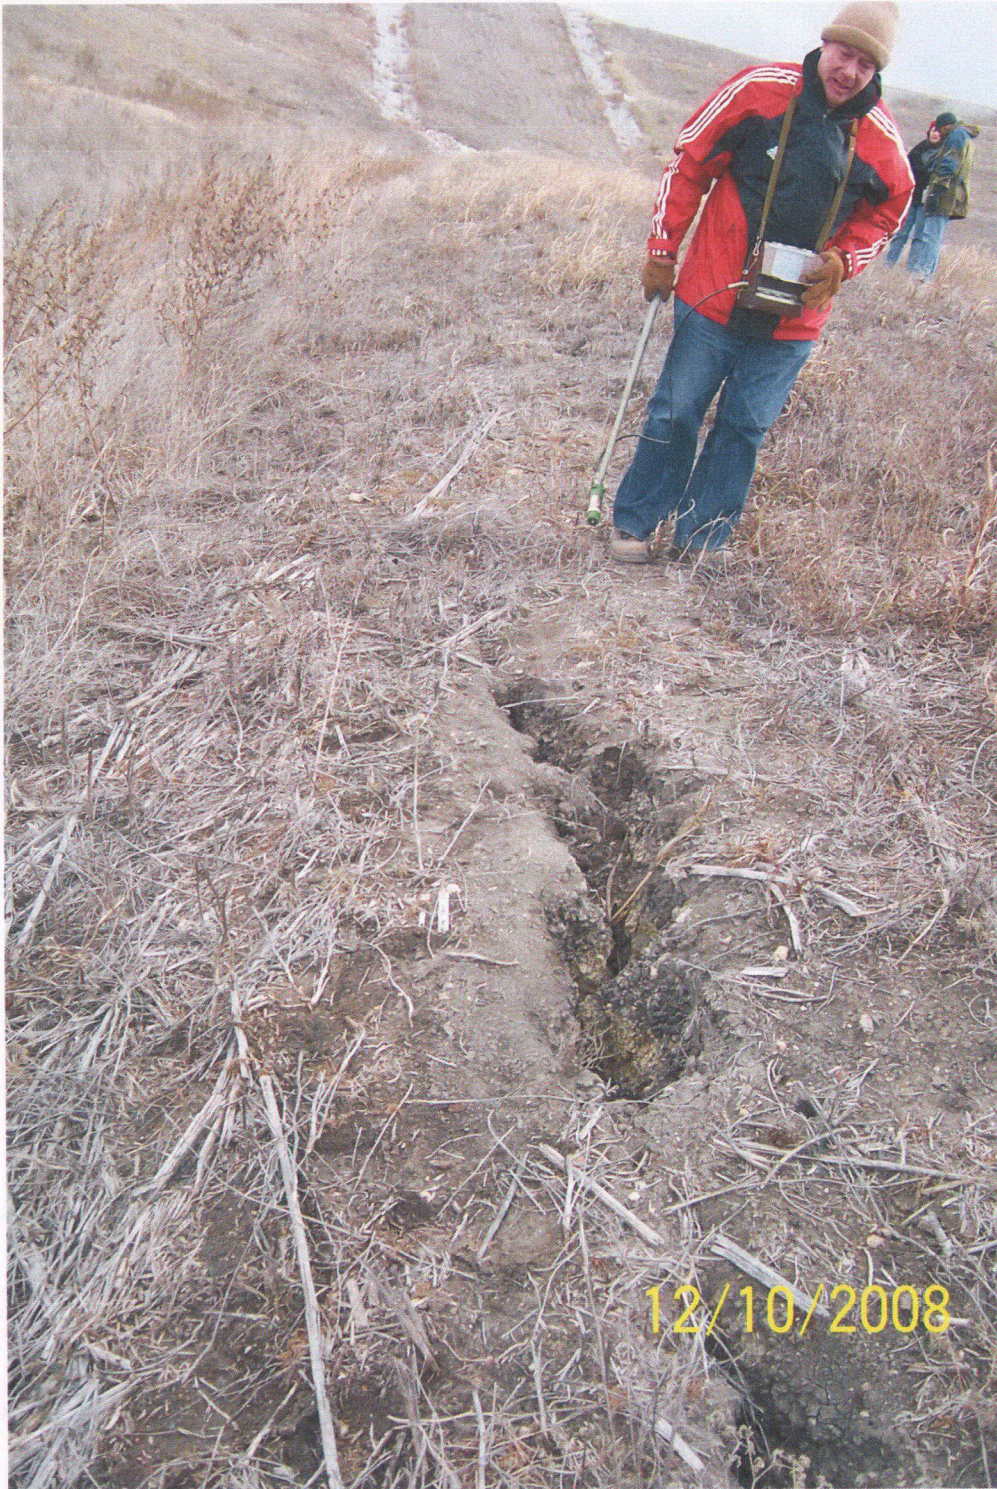
A “tension crack” on the north side of the IWU at the top of the slope.
