**SUBJECT: Municipal Solid Waste – Travis County
Austin Community Recycling and Disposal Facility – Permit No. MSW 249-C
Repair Report and Interim Status Report for Cell WD-3**

**AUSTIN COMMUNITY RECYCLING
AND DISPOSAL FACILITY**

**REPAIR REPORT FOR A PORTION OF THE
SIDEWALL DRAINAGE LAYER FOR CELL WD-3**

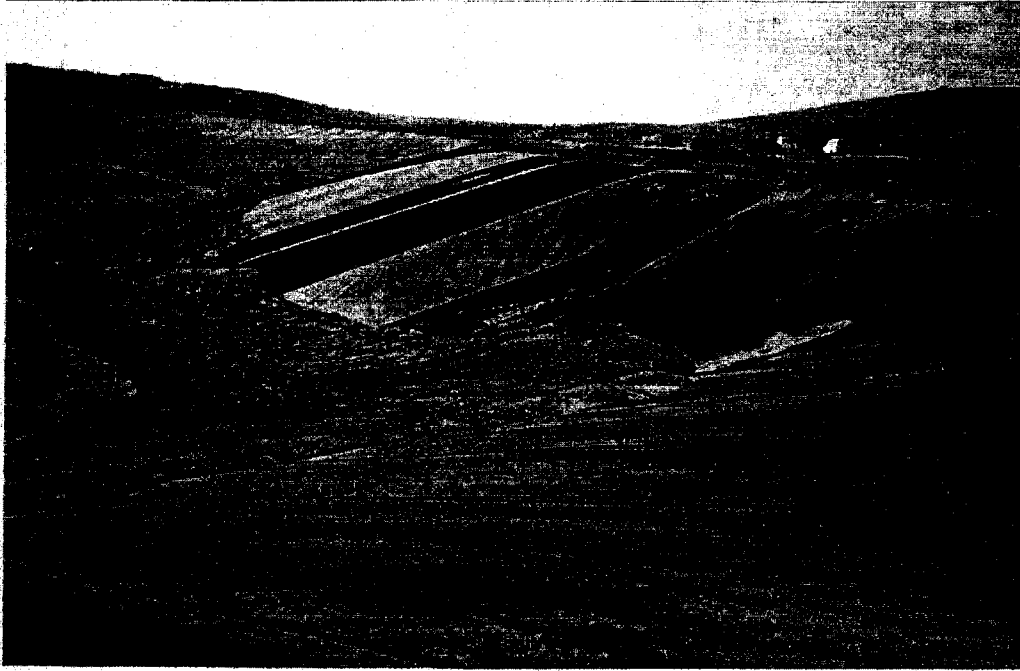
This report documents oversight of repairs to a portion of the Cell WD-3 liner system provided by Earth Tech, Inc., at the Austin Community Recycling and Disposal Facility during January 1999. Due to heavy rains, the protective cover on a section of the northwest slope of Cell WD-3 (between approximately N + 70 and P + 40) became saturated and slid down the slope, pulling the geonet and geotextile layers (but not the high density polyethylene (HDPE) liner) out of the anchor trench and also down the slope. Cell WD-3 was originally approved for use on October 27, 1998, but disposal operations had not been initiated at the time of the slide or repair.

Cell WD-3 Northwest Sideslope
Geonet/Geotextile Slippage Area Prior to Repair
View Toward Southwest
January 5, 1999

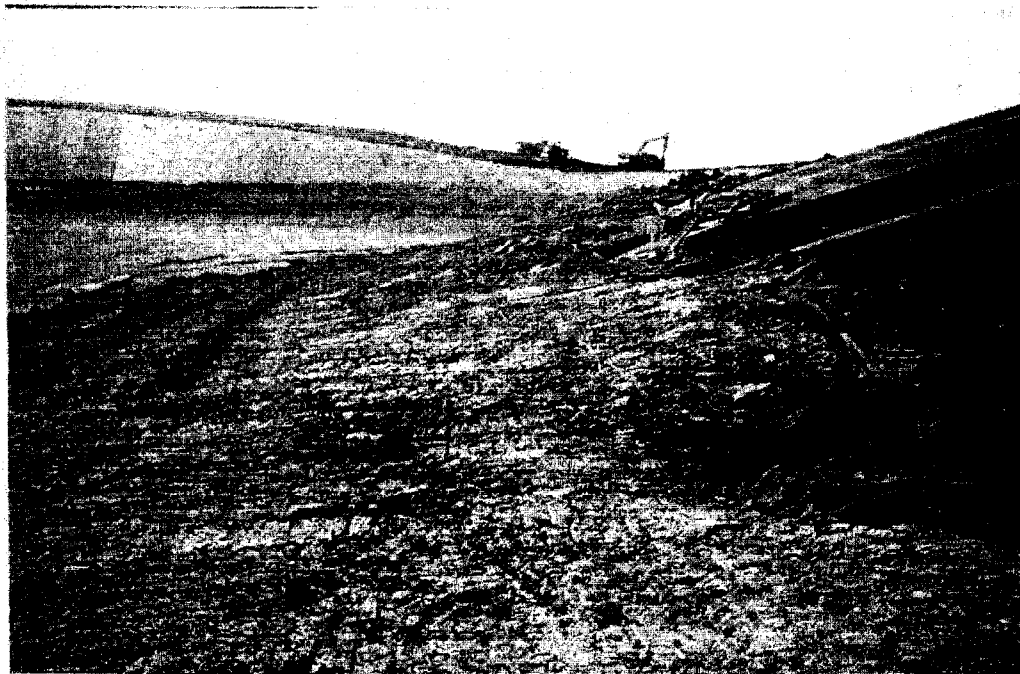
Cell WD-3 Northwest Sideslope
Geonet/Geotextile Slippage Area at Toe of Slope Prior to Repair
View Toward South
January 5, 1999

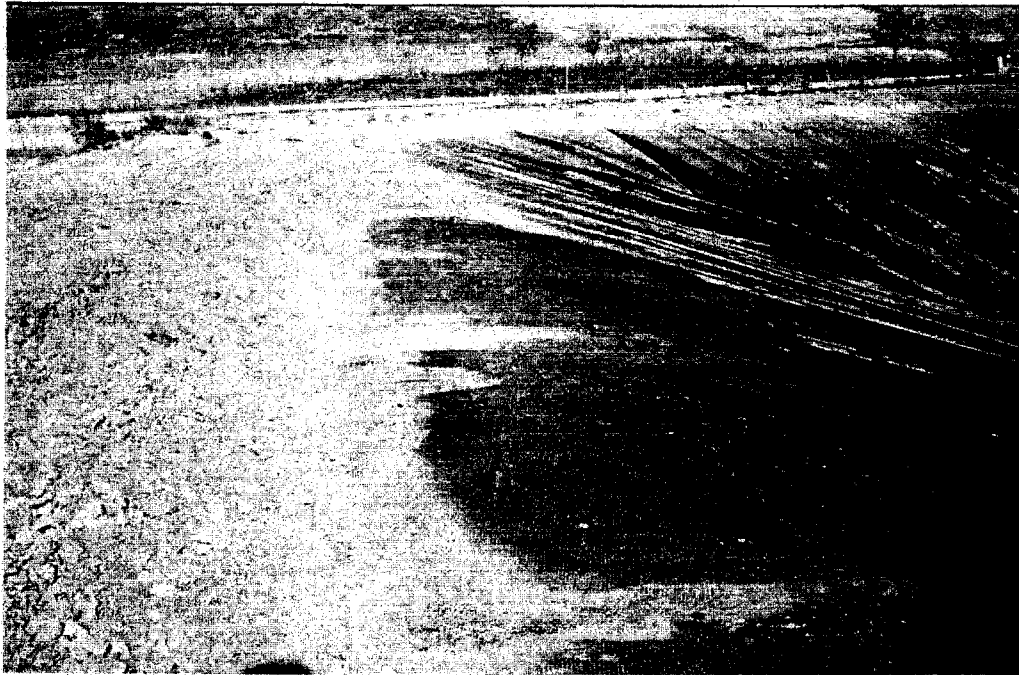
Cell WD-3 Northwest Sideslope
Geonet/Geotextile Slippage Area at Top of Slope Prior to Repair
View Toward North
January 5, 1999

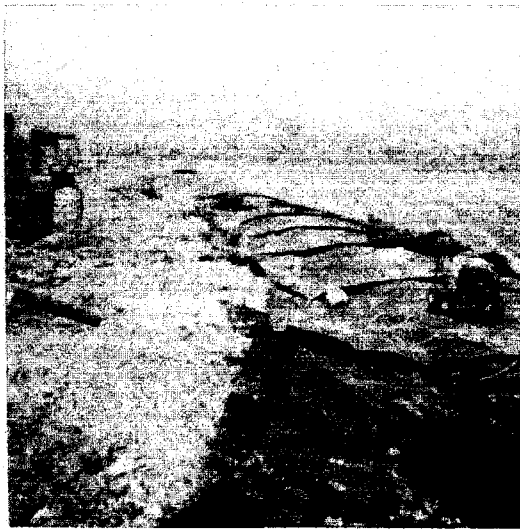
Cell WD-3 Northwest Sideslope
Deployment of Geotextile at Top of Slope
View Toward North
January 7, 1999

The geotextile, a 16 ounce-per-square-yard non-woven polypropylene fabric, was then deployed over the geonet. The seams were sewn with portable hand-held sewing machines using polymeric thread with chemical and ultraviolet light resistance equal to or greater than those of the geotextile. A CQA technician observed and documented that the installation was in accordance with the SLQCP.

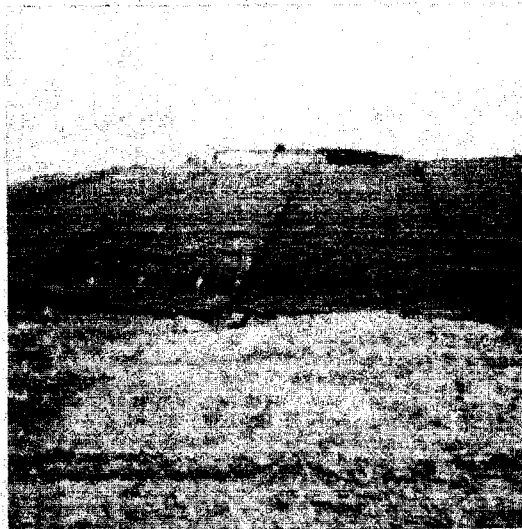
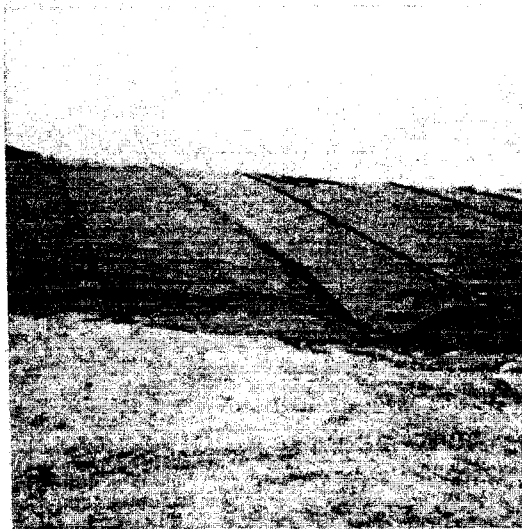
Cell WD-3 Northwest Sideslope
Geonet/Geotextile Slippage Area After Repair
View Toward West
January 7, 1999

National Seal Company arrived on-site January 7, 1999 to replace geonet and geotextile materials which slid down the slope. The compromised materials were removed and discarded. Replacement HDPE geonet was deployed down the slope and seams were tied at maximum five foot intervals using plastic ties. A construction quality assurance (CQA) technician observed and documented that the installation was in accordance with the site-specific Soils and Liner Quality Control Plan (SLQCP).
