KETTLEMAN HILLS WASTE LANDFILL SLOPE FAILURE. II: STABILITY ANALYSES

By Raymond B. Seed,¹ Associate Member, ASCE, James K. Mitchell,² Fellow, ASCE, and H. Bolton Seed,³ Honorary Member, ASCE

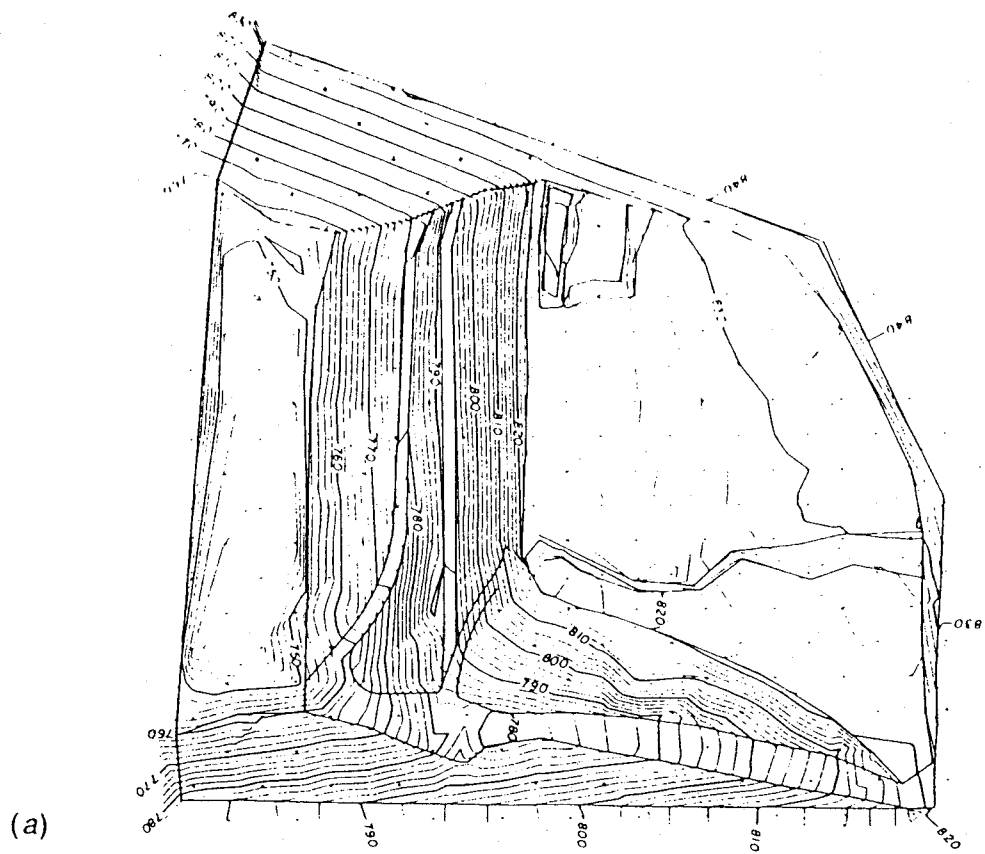
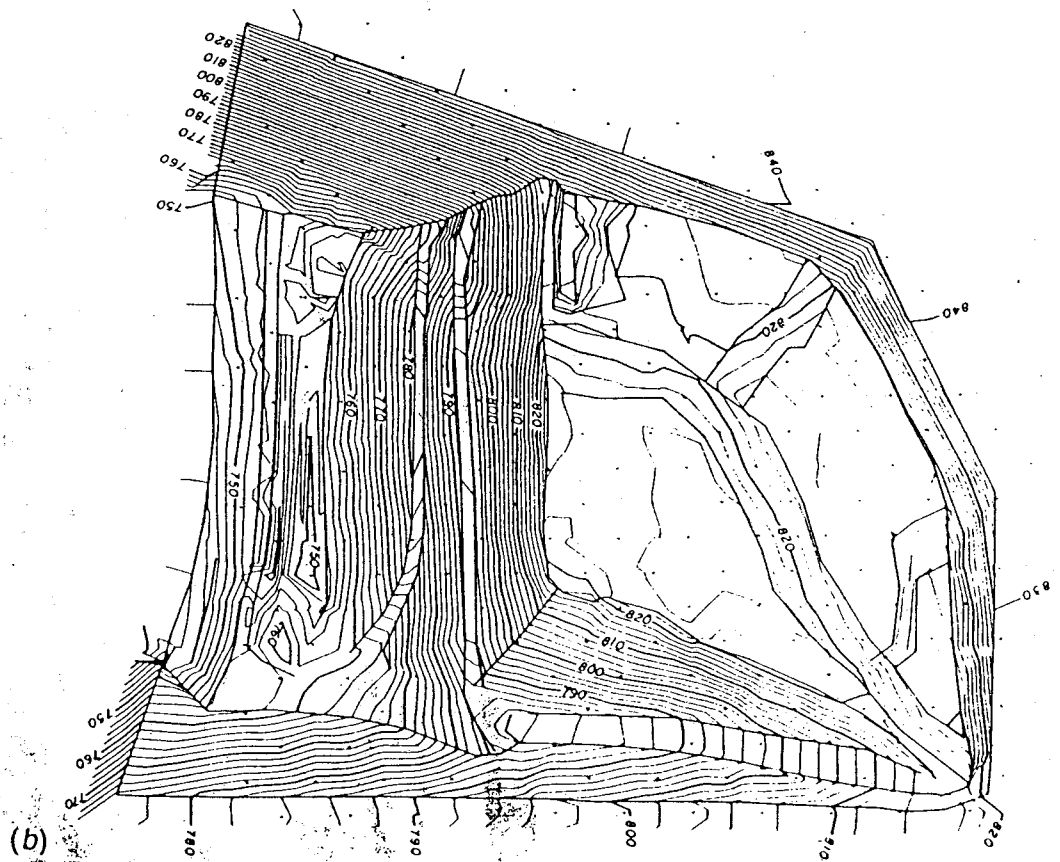
FIG. 3.— Surface Topography of Unit B-19, Phase 1-A Landfill: (a) Preslide Topography on March 15, 1988; (b) Postslide Topography

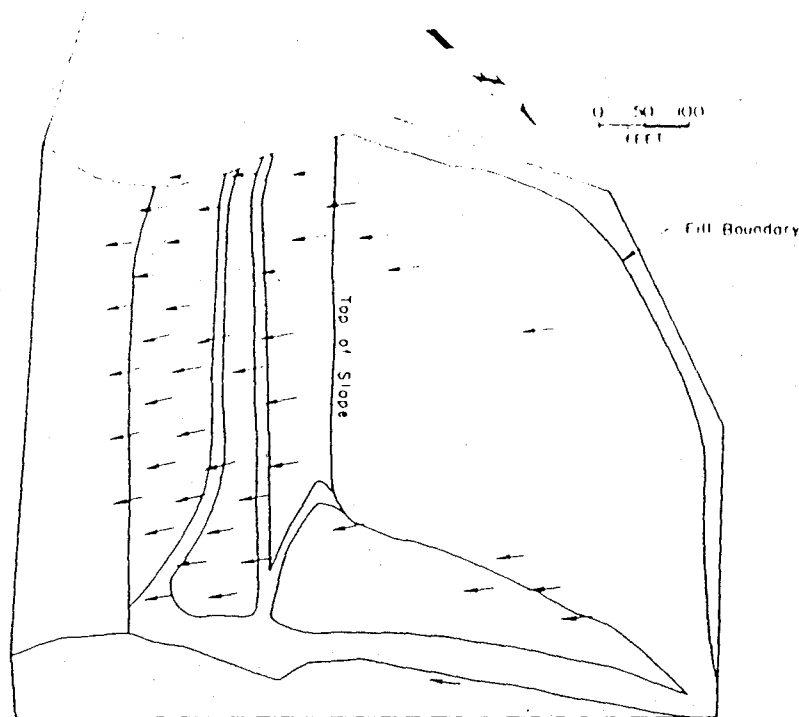
FIG. 4. Plan View Showing Displacement Vectors Representing Measured Lateral Movements Due to Slide

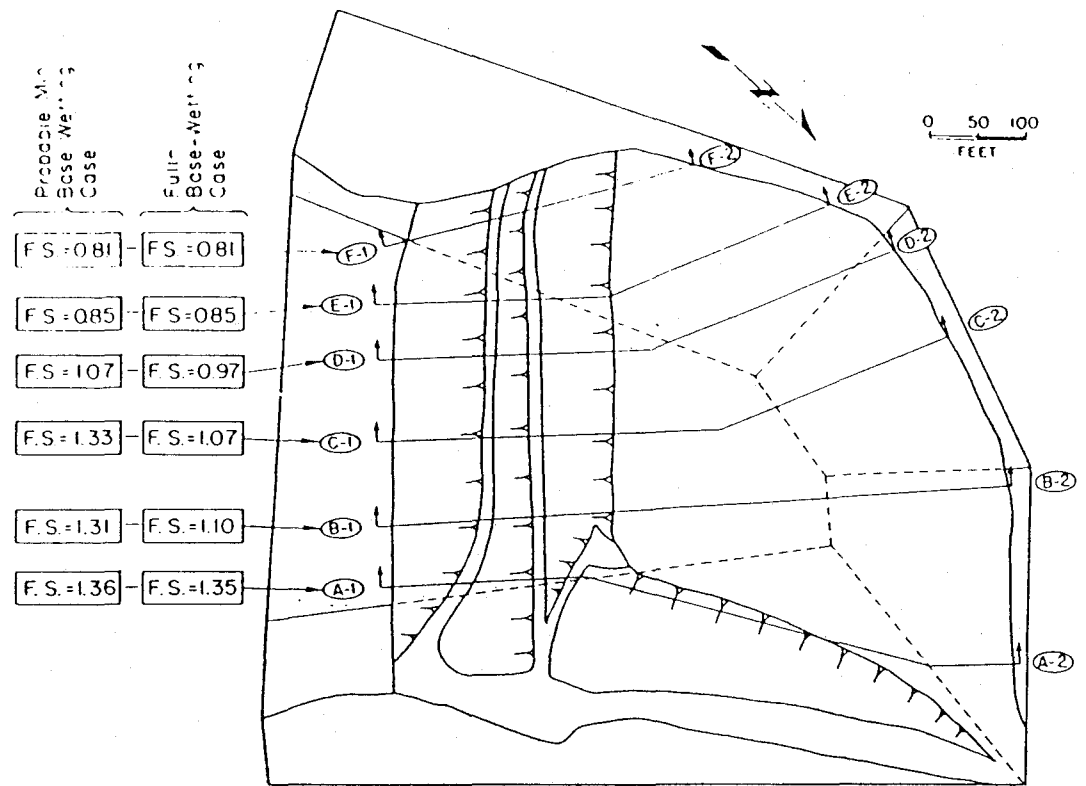
Fig. 8 shows the results of these stability analyses for six cross sections under Probable Minimum Clay/Liner Wetting Case conditions. As shown in this figure, Sections A-1/A-2, B-1/B-2, and C-1/C-2, which together represent more than half of the overall waste-fill mass, all have calculated factors of safety of F.S. = 1.33 to 1.36. Conditions become somewhat less stable toward the southwest side of the landfill, and Section D-1/D-2 has a calculated factor of safety of F.S. = 1.07. It is only at the extreme southwest side of the landfill that factors of safety of less than 1.0 are calculated; the computed factor of safety for Sections E-1/E-2 and F-1/F-2, are F.S. = 0.85 and 0.81, respectively. As the factors of safety for Sections E-1/E-2 and F-1/F-2 are only slightly less than 1.0, and as these two sections represent only a very small portion of the overall waste-fill mass, it appears unlikely that these two sections could trigger a progressive slope failure beginning at the southwest end of the landfill. This is particularly so in view of the fact that analyses of all six cross sections were based on residual strengths, so that consideration of the effects of strain-softening along the failure surfaces, necessary for progressive failures of this type, is already included in the computed factors of safety. By weighting each plane-section factor of safety shown in Fig. 8 in proportion to the mass of the fill near the plane that might be considered “tributary” to the plane section, the factor of safety of the overall fill mass can then be estimated to be on the order of F.S. \approx 1.15 to 1.25.

FIG. 8. Results of Two-Dimensional Slope-Stability Analyses of Sections A-1/A-2 through F-1/F-2 for Probable Minimum Base Wetting Case Conditions and Full-Base-Wetting Case Conditions

Fig. 8 also shows the results of stability analyses for Full-Base-Wetting Case conditions for the same six cross sections considered previously. The calculated factors of safety for Sections A-1/A-2, E-1/E-2, and F-1/F-2 are essentially unchanged from those calculated previously for the Probable Minimum Clay/Liner Wetting Case conditions, because they are negligibly affected by the assumed larger zone of "wetted" HDPE liner/compacted clay liner failure surface. The three centrally located cross sections, which traverse the enlarged zone of "wetted" HDPE liner/compacted clay liner interface-shear failure assumed for this Full-Base-Wetting Case, show reductions in their calculated factors of safety. The resulting factors of safety for Sections B-1/B-2, C-1/C-2, and D-1/D-2 are F.S. = 1.10, 1.07, and 0.97, respectively.

As shown in Fig. 8, for the six cross sections considered, the calculated factors of safety generally decrease from northeast to southwest across the fill for Full-Base-Wetting Case conditions. The calculated factors of safety are greater than 1.0 for the four sections (Sections A-1/A-2 through D-1/D-2) representing the northeast and central portions of the waste fill, though for the centrally located Sections B-1/B-2 through D-1/D-2, the calculated factors of safety are significantly less than for the Probable Minimum Clay/Liner Wetting Case.

As the factors of safety for Sections E-1/E-2 and F-1/F-2 are only slightly less than 1.0, and as these two sections represent only a very small portion of the overall waste-fill mass, it again appears unlikely that these two sections could trigger a progressive failure, particularly because (1) These analyses are once again based on residual liner-interface-shear strengths; and (2) the more stable cross sections A-1/A-2, B-1/B-2 and C-1/C-2 represent significantly more than half of the overall waste-fill mass. Although these two-dimensional analyses of six representative cross sections for Full-Base-Wetting Case conditions result in the calculation of somewhat lower factors of safety than did the analyses described for the Probable Minimum Base Wetting Case conditions, they do not appear to represent a clear condition of overall slope instability. Based on the calculated factors of safety for the six cross sections shown in Fig. 8, the factor of safety of the overall fill mass might be estimated to be on the order of F.S. \approx 1.1. This factor of safety, though low, is based on residual interface-shear strength for "worst case" possible wetting conditions, and is not clearly indicative of a level of

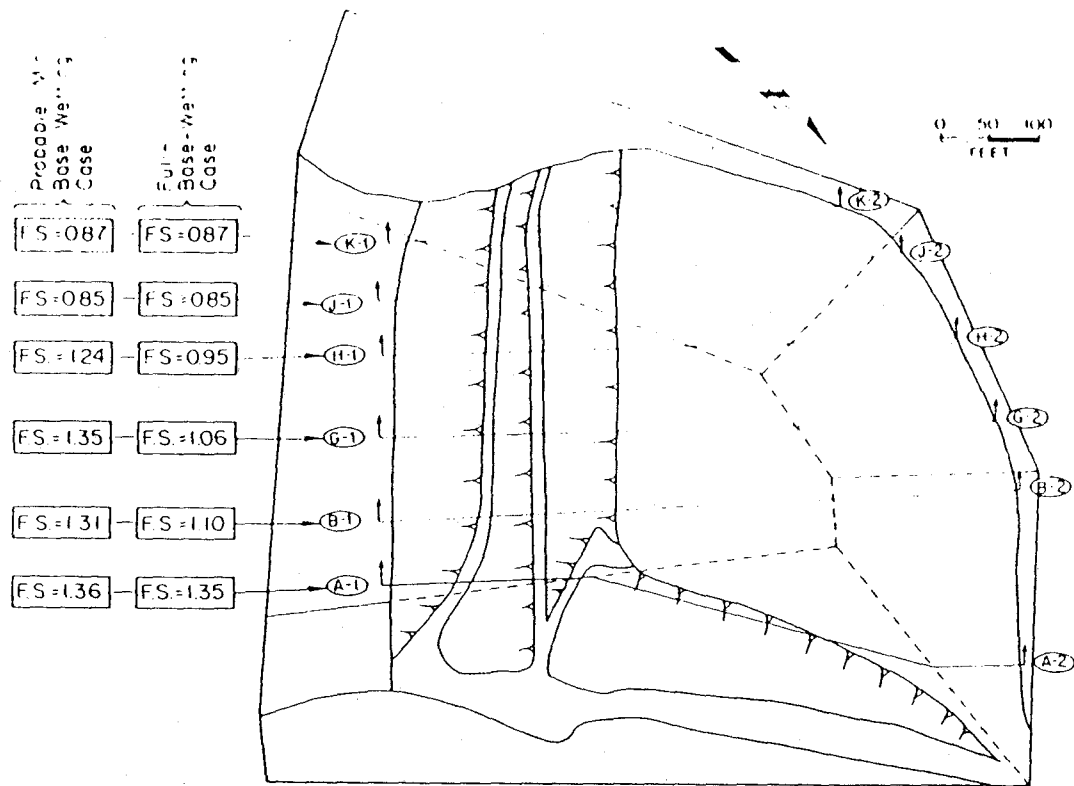
The results of similar analyses for six planar sections, including two of the sections previously discussed, Sections A-1/A-2 and B-1/B-2, are shown in Fig. 9. The overall factor of safety is about the same as that determined for the nonplanar sections. It would appear from these results for the Prob-

FIG. 9. Results of Two-Dimensional Slope-Stability Analyses of Sections A-1/A-2, B-1/B-2, and G-1/G-2 through K-1/K-2 for Probable Minimum Base Wetting Case Conditions and Full-Base-Wetting Case Conditions

Similar results are shown in Fig. 9 for six planar cross sections through the fill. Once again, the results of the analyses of the planar sections are very similar to the results of the analyses of the nonplanar sections.

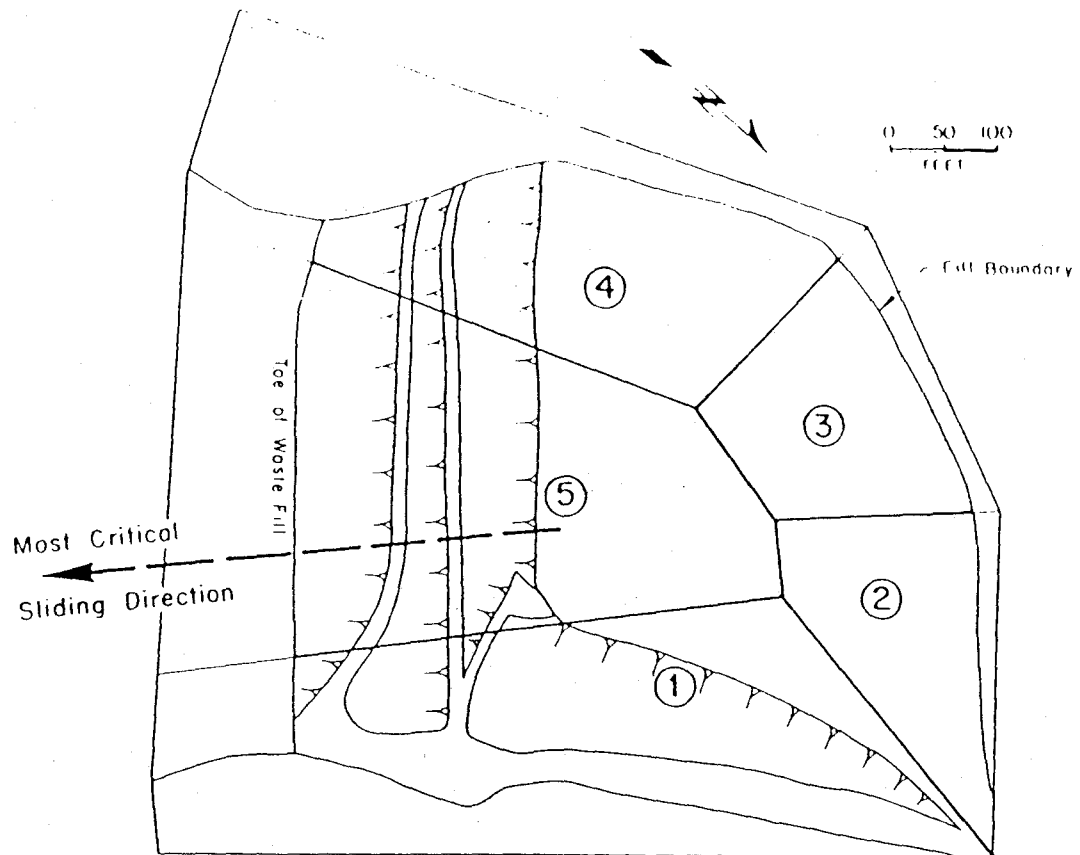
FIG. 10. Plan View of Landfill Showing Five Block Masses Used for Three-Dimensional Force-Equilibrium Stability Analyses, and Resulting Critical Sliding Direction

This required iteration of the "trial" factor of safety to achieve convergence. The ("converged") factor of safety was determined by this procedure for a number of different assumed directions of sliding in order to find the most critical sliding direction and the associated most critical (lowest) factor of safety for both the Probable Minimum Base Wetting Case conditions and the Full-Base-Wetting Case conditions. The resulting computed factors of safety were for the Probable Minimum Base Wetting Case conditions, $FS = 1.14$; and for the Full-Base-Wetting Case conditions, $FS = 1.06$. These values are somewhat lower than the overall factors of safety estimated from the results of the two-dimensional stability analyses. It is interesting to note that these force-equilibrium analyses show the most critical potential sliding direction (the assumed direction of sliding that results in the lowest calculated overall factor of safety) to be in close agreement with the actual observed direction of sliding, as shown in Figs. 4 and 10.

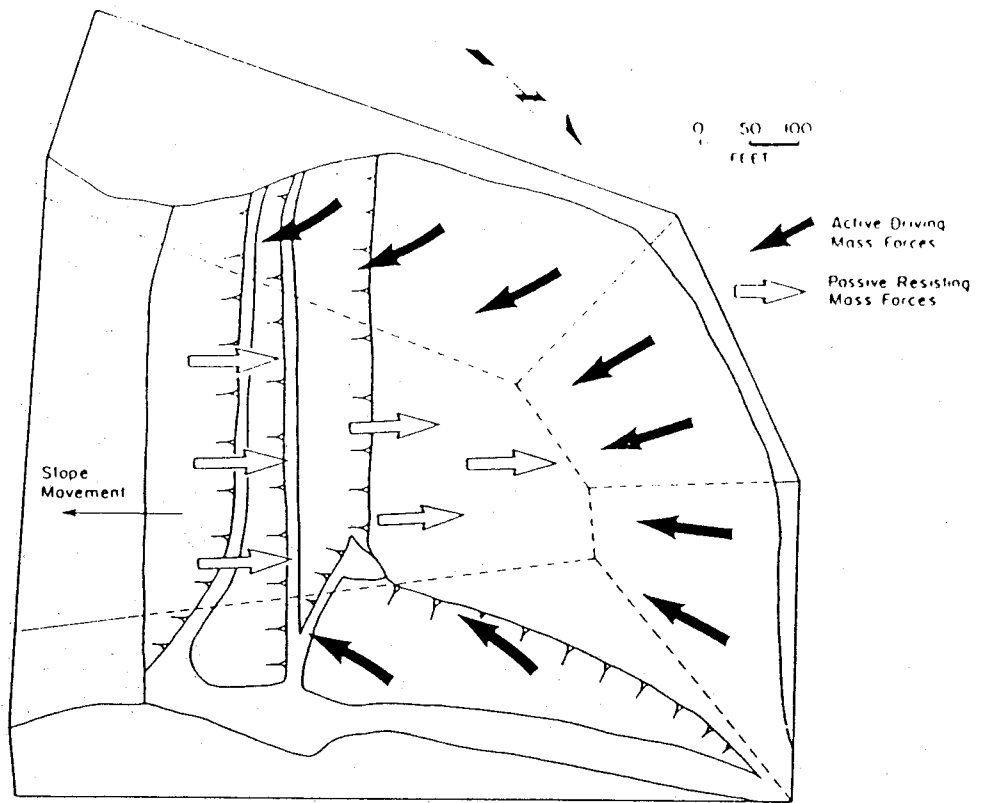
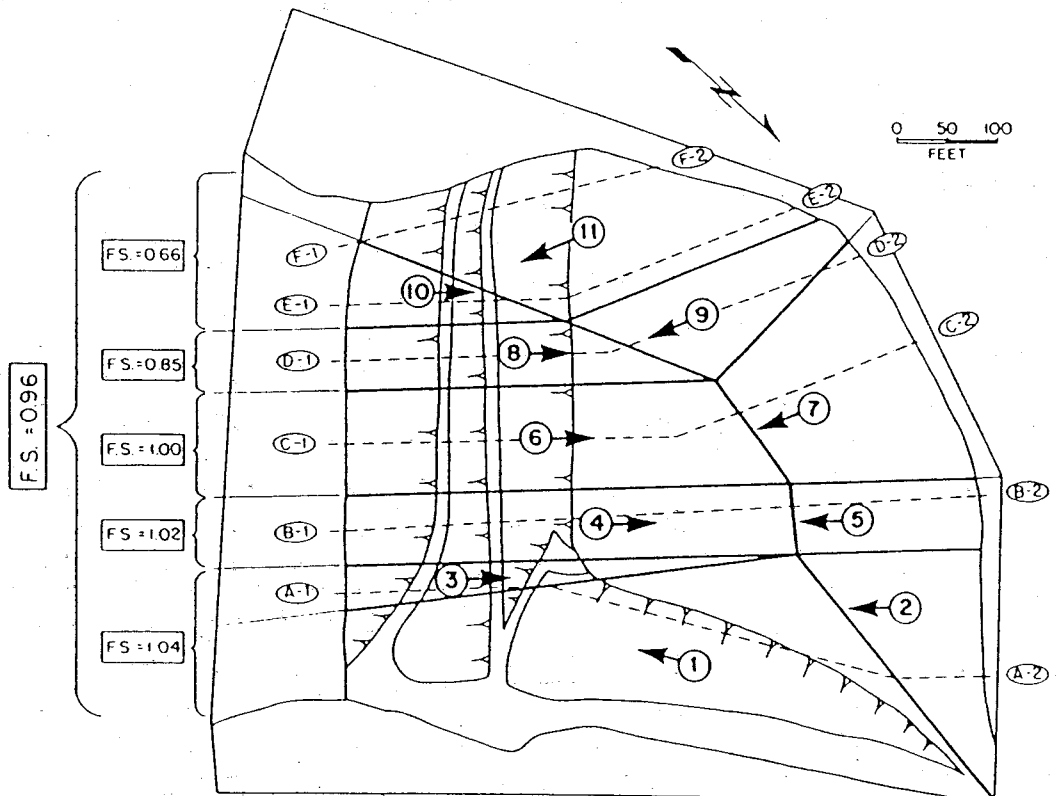
FIG. 11. (a) Schematic Illustration of Three-Dimensional Failure Mechanism; and (b) Results of Multiblock Analysis

Fig. 11(b) shows the results of such an analysis for the Phase I-A landfill under Probable Minimum Clay/Liner Wetting Case conditions. As shown in this figure, the estimated overall factor of safety for the whole waste fill mass is $F.S. = 0.96$, which is about 20% lower than the factor of safety estimated on the basis of the two-dimensional (2D) analyses of six representative cross sections using the same liner-interface-shear-strength parameters, and about 15% lower than the factor of safety computed by the three-dimensional force-equilibrium analyses. However, the analysis results do not perfectly satisfy overall translational equilibrium requirements. To perfectly satisfy translational equilibrium, the sum of the force vectors acting on the basal sliding planes underlying each of the 11 fill blocks should be a single force vector, perfectly vertical and equal in magnitude to the overall weight of the fill mass. The actual summed base forces produce a "resultant" force vector that is not quite vertical: the vertical resultant is approximately 2% less than the total fill weight, and there are horizontal resultant components equal to approximately 3.7% of the total fill weight in the direction of sliding and 1.5% in the direction orthogonal to the direction of sliding. While these unbalanced forces may appear small, the analytical results are clearly sensitive to the magnitude of unbalanced forces considered to be acceptable in any given case. Nevertheless the approach does lead to a varying factor of safety across the width of the fill mass, with the lowest stability occurring at the southwest side of the fill mass, which seems to be in better accord with the observed mode of failure than the development of a single factor of safety for the system as a whole.
