**130 ENVIRONMENTAL PARK**  
**APPENDIX IIF**  
**CULTURAL RESOURCES SURVEY**

**CULTURAL RESOURCES SURVEY  
OF THE  
130 ENVIRONMENTAL PARK  
TRACT  
CALDWELL COUNTY, TEXAS**

Cultural Resources Report 2013-43  
August 30, 2013

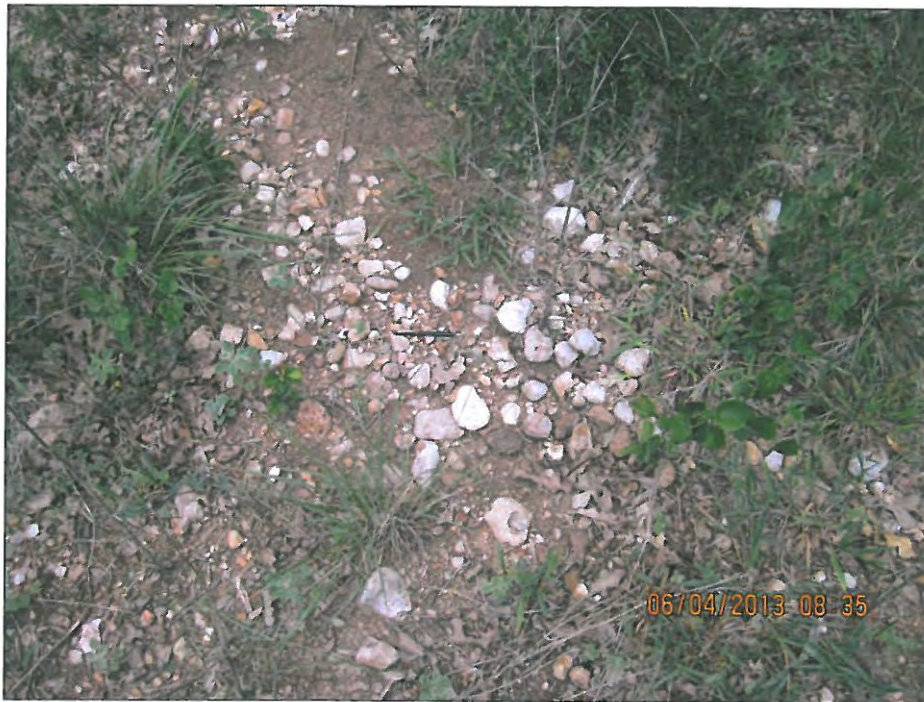
Figure 10. Close-up of chert cobbles on eroded ground surface west of the transmission corridor. The black pen in the center of the picture provides a scale.

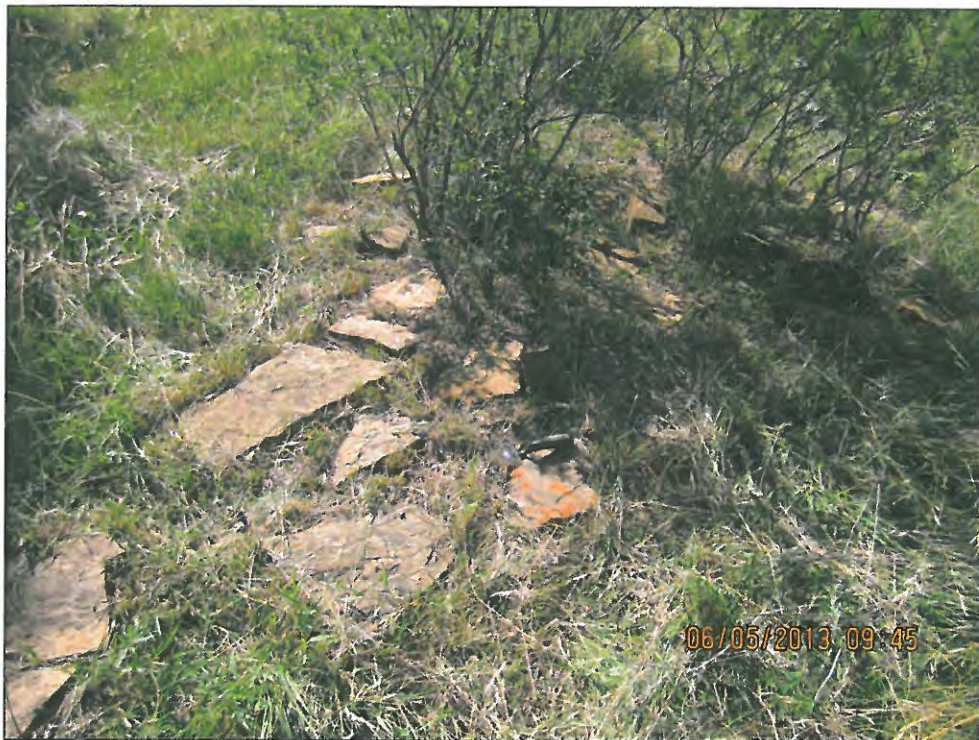
Also identified during the survey were several push or scrap piles of wood and metal, but the materials all appeared to be from the mid-1900s and there were no diagnostic artifacts. These piles most likely represent the razing of fences and pens prior to farming of the various fields. A concentration of thirty sandstone slabs was found in a roadway south of the seed-shaped stock tank previously mentioned. The slabs range in size from 24 by 12 in to 8 by 9 in and have a thickness range of 3.5 to 5.5 in (Figure 11). They are lying flat in an area 12.5 ft (north-northwest/south-southeast) by 6 ft but do not form a recognizable pattern. No historic artifacts were found associated with the slabs and the clay soil contained small cobbles.

Figure 11. Sandstone slabs concentrated in a bulldozed road south of the seed-shaped stock tank. View is to the southeast.

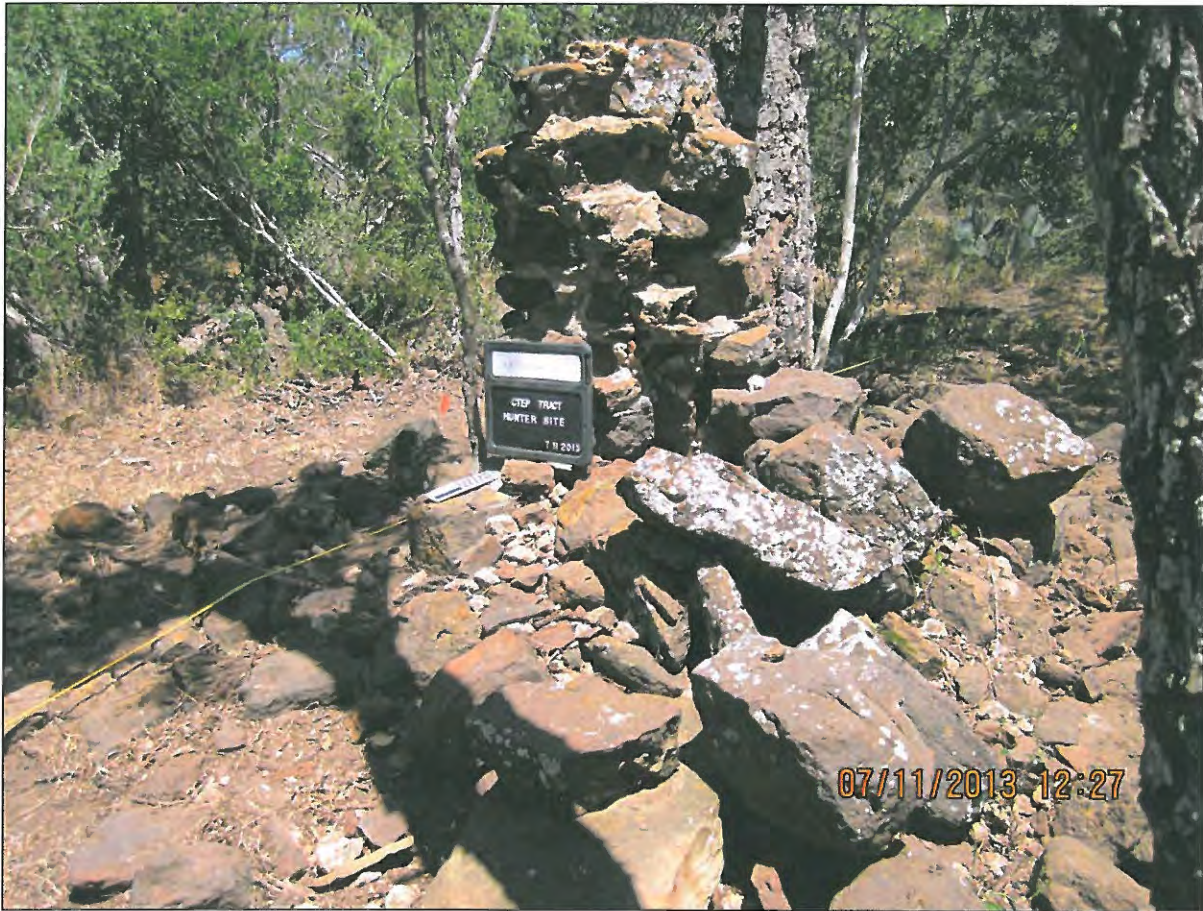
The rock fireplace and chimney have a footprint that is 3 ft deep and 6 ft wide with the opening to the south (Figure 14). The walls and hearth are made of roughly-shaped sandstone blocks that are very dark grayish brown (10YR3/2) in color and contain lighter colored sand. The chimney walls consist of rocks that are mortared together to create a wall that averages 10-11 in thick.

Much of the mortar has eroded away; it only remains between existing rocks of the chimney wall. The chimney stands 43.5 in above the hearth surface and the hearth surface is roughly 12 in above the adjacent ground surface. The chimney fall surrounds the remnant of the standing chimney and covers an area 5 ft to the south, 6 ft to the north, 2 ft to the east, and 2-3 ft to the west. Based on this fall area and the size of the rocks, the chimney is estimated to have been 10-12 ft tall. The rocks that make up the chimney are not present naturally in the immediate area but were quarried and shaped to be used for this purpose.

Figure 13. The rock chimney prior to excavation, looking northwest.

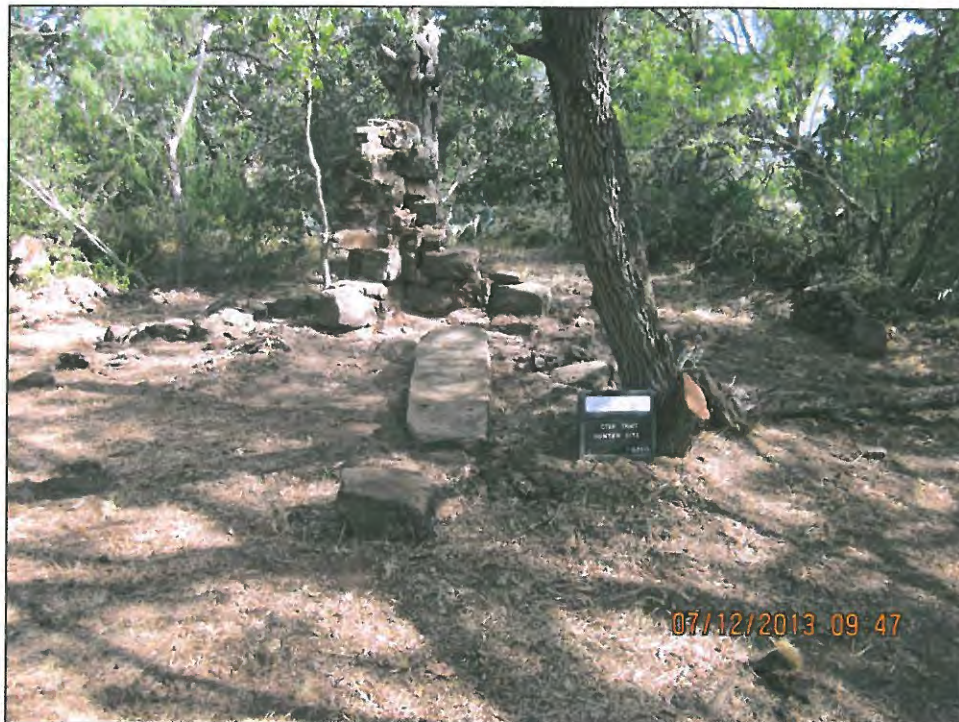
The interesting feature of the chimney fall is a thick sandstone slab that was likely a hearth stone. The slab is 53 in long, 16 in wide, and 6 in thick and could not have been lifted into place by a single person. The sandstone is thinly laminated, well cemented, and is light yellowish brown (10YR6/4) in color. This appears to be an unusual feature as Jordan (1978) does not mention the incorporation of slab hearths in log cabin chimneys.

Figure 15. The Hunter site (41CW159), facing north. Note the large, sandstone slab in front of the chimney.

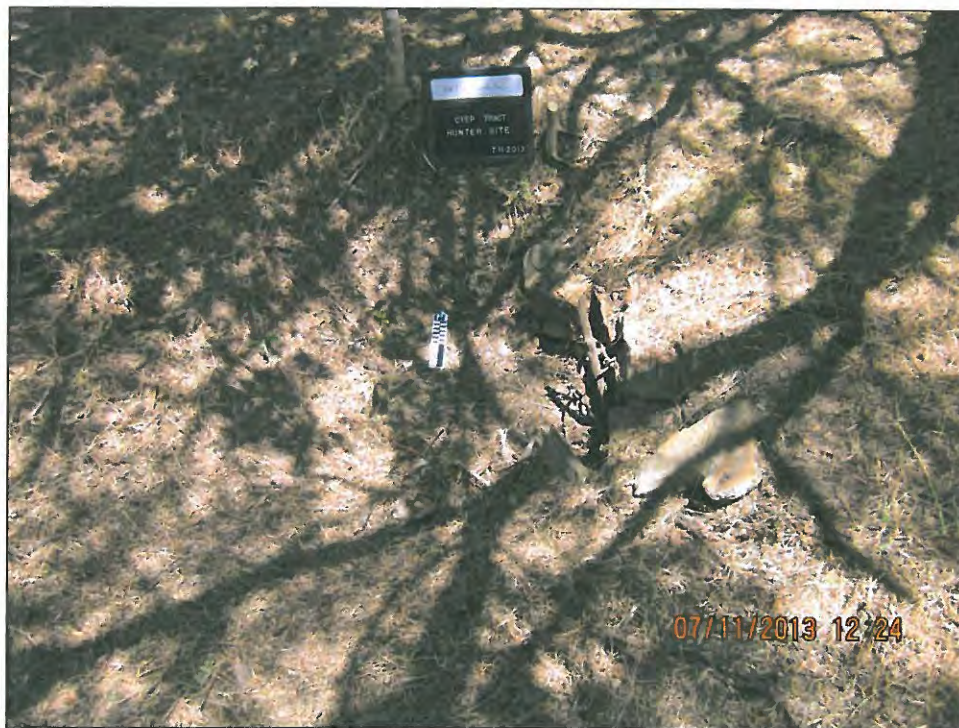
The northeast side of a cistern collar is preserved in the wall of a 3-foot-deep hole located 25 feet southeast of the hearth base (Figure 15). The cistern has an interior diameter of 30-36 in. No mortar was noted between the light yellowish brown sandstone blocks that make up the rock-lining, nor was any mortar apparent on the inner surface of the remaining wall section. Rock,

Figure 16. The northeast side of the stone-lined cistern collar is in place below the level of the present ground surface. The remainder of the lining and probably the above ground rock collar has probably fallen into the cistern vault.
