**130 ENVIRONMENTAL PARK**  
**APPENDIX IID**  
**WETLANDS DOCUMENTATION**

# **WATERS OF THE UNITED STATES DELINEATION REPORT AND WETLAND DETERMINATION AND IDENTIFICATION**

**130 Environmental Park**

**AVO 29520**

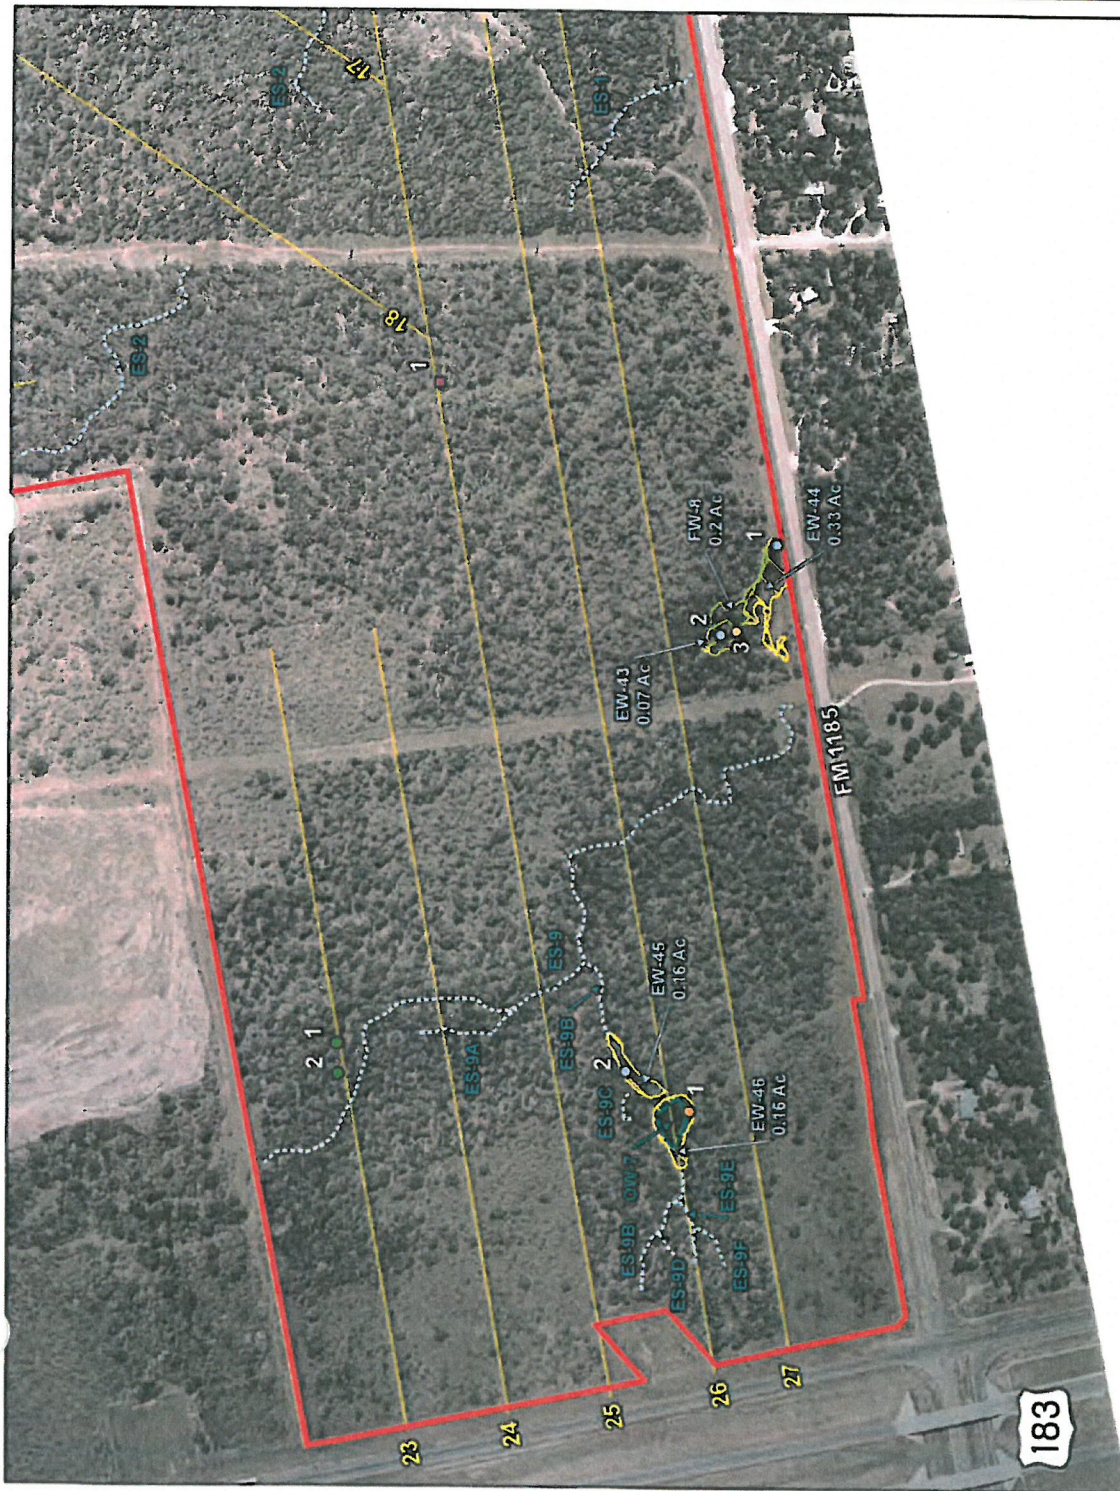
Project Title: 130 ENVIRONMENTAL PARK
Project Number:
Date: 08/2013 AVO: 29520
Sheet Title: WATERS OF THE UNITED STATES MAP
Sheet Number: FIGURE - 3.5

Name	Figure Location	Stream Classification	Length (ft)	OHWM Width (ft)
ES-9	3.5	Ephemeral	2,453	8-10
ES-9A	3.5	Ephemeral	306	3-10
ES-9B	3.5	Ephemeral	605	3-10
ES-9C	3.5	Ephemeral	96	4-5
ES-9D	3.5	Ephemeral	78	3
ES-9E	3.5	Ephemeral	187	3
ES-9F	3.5	Ephemeral	148	3-6

This is a smaller stream system located in the southwestern portion of the study area. The main ES-9 channel is an 8 to 10 foot wide cobbled channel flowing north to south within dense post oak woodland. The channel was smaller and less incised in comparison with IS-1 and there was little evidence of cattle grazing in this portion of the study area. ES-9 is joined by a smaller headwater stream system from the west, which included one on-channel open water pond (OW-7) and an on-channel emergent wetland (EW-45) downstream of the pond dam. Near the

southern study area boundary, ES-9 outfalls into a culvert under FM 1185 and multiple emergent and forested wetlands (EW-43, EW-44, and FW-8) were observed adjacent to the channel in this area.
