**130 ENVIRONMENTAL PARK**

**APPENDIX IIE  
ENDANGERED OR THREATENED SPECIES DOCUMENTATION**

Re: Threatened and endangered species assessment for the proposed 130 Environmental Park in Caldwell County, Texas

**WILDLIFE HABITAT ASSESSMENT PROGRAM  
QUESTIONNAIRE FOR  
THREATENED AND ENDANGERED SPECIES**

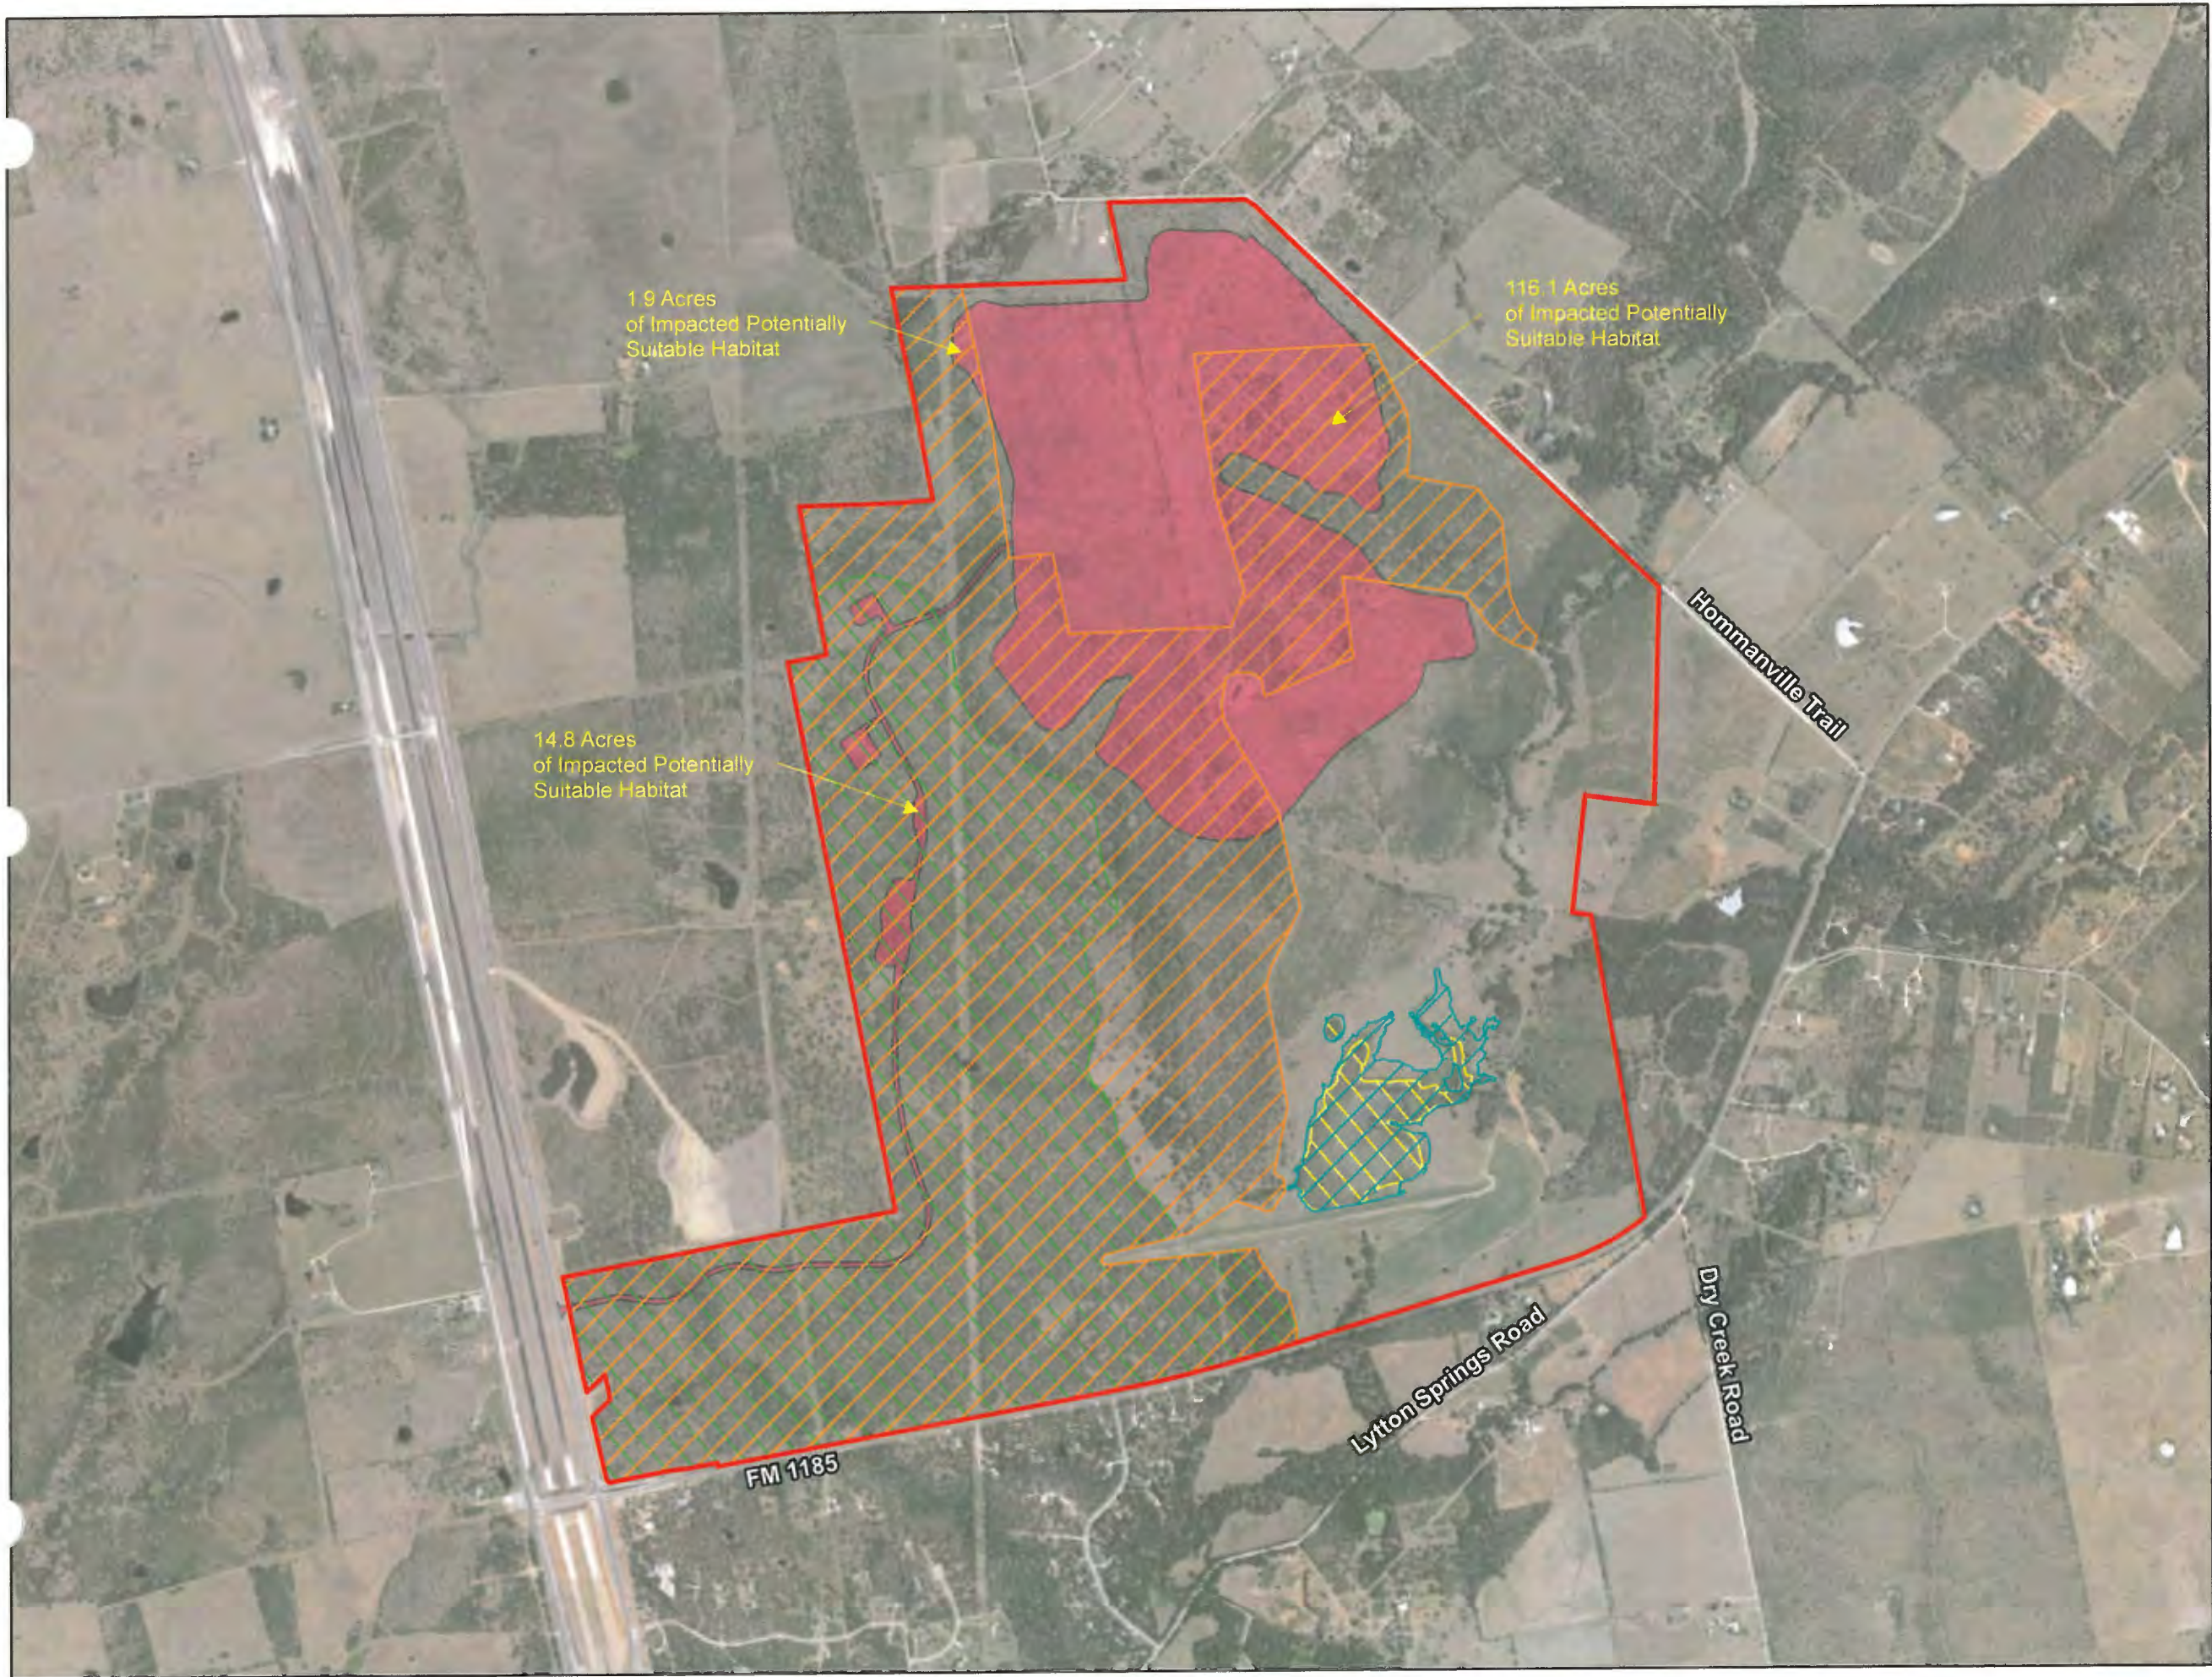
- Study Area
- Wood Stork
- Golden Orb & Texas Pimpleback
- Timber/ Canebrake Rattlesnake
- Texas Horned Lizard
- Project Impact Area

The study area represents the western edge of the timber rattlesnake's range, and includes conditions that may be suitable for this snake. Timber rattlesnakes are found in upland woods, rocky ridges, and moist lowland forests or thickets near permanent water sources such as rivers, lakes, ponds, streams and swamps where tree stumps, logs and branches provide refuge. Within the study area, the areas that may provide suitable habitat for the timber rattlesnake are the forested areas in close proximity to stream corridors. A conservative (overly-inclusive) depiction of these areas is shown on **Figure 3**.

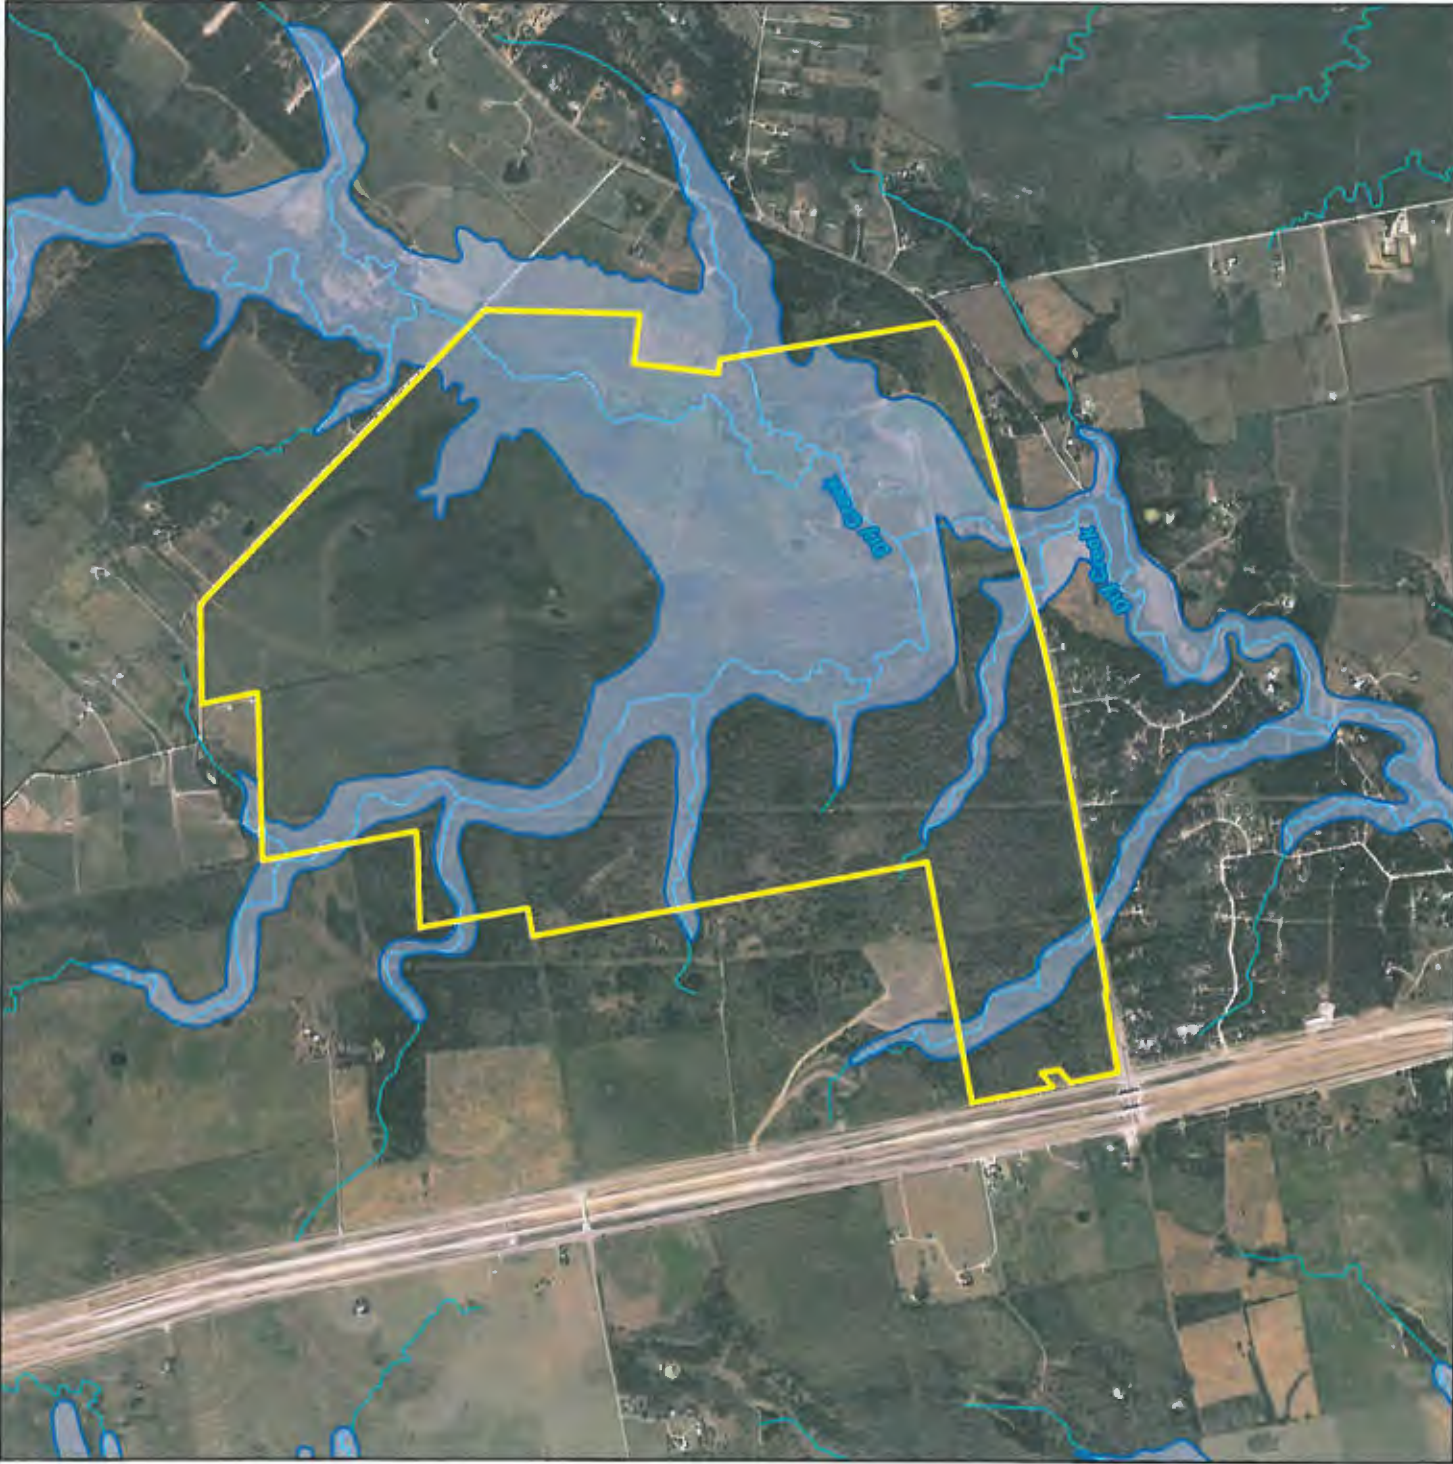
| Sheet Number: FIGURE 5 |

| Sheet Title: SOIL SURVEY MAP |

According to the Natural Resource Conservation Service Soil Data Mart, the following soils are mapped within the property boundary. A map (Figure 5) of the soils is attached.

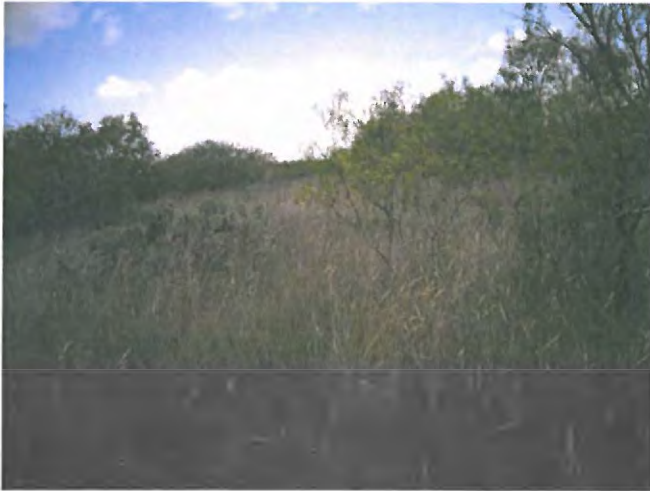
### **Mesquite Grassland Mosaic**

This was one of the most frequently encountered vegetation communities within the study area. Dominant vegetation included mesquite scrub, prickly pear, pencil cactus, Texas persimmon, agarita, Texas wintergrass, lemon bee balm, and plains coreopsis.

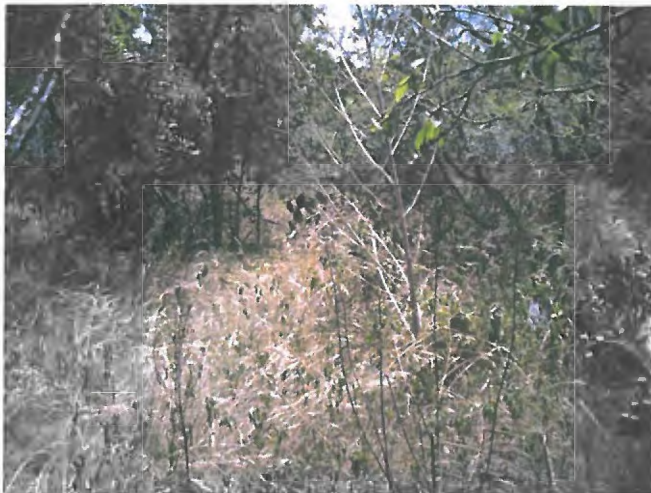
### **Mesquite Woods**

This community was similar to the mesquite grassland mosaic, and occurred at the transition to more wooded areas. Dominant vegetation in this community included large mesquite trees, cedar elm, post oak, hackberry, agarita, Texas persimmon, prickly pear, pencil cactus, and Texas wintergrass.

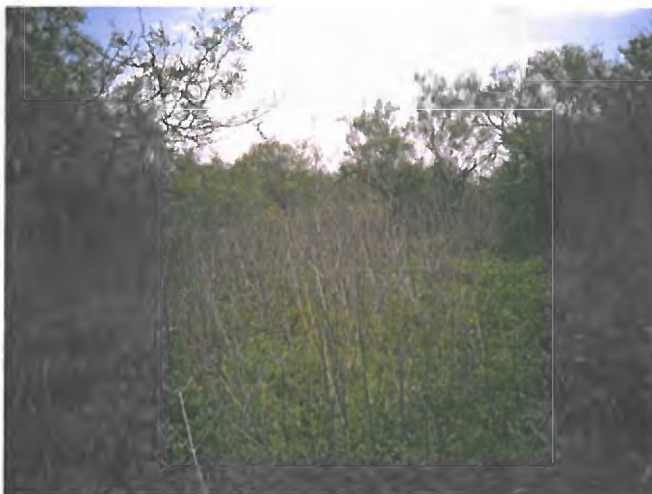
### **Sumpweed Depression Wetlands**

Dominant vegetation in this community included sumpweed and common spikerush. These depressions were emergent wetlands occurring in terraced areas of the surrounding uplands and typically occurred within the mesquite grassland mosaic.

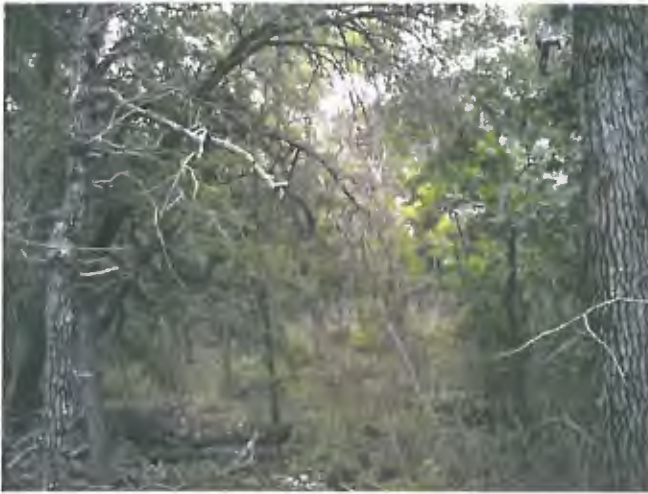
### **Post Oak/ Cedar Elm Woods**

Dominant vegetation in this community included post oak, cedar elm, yaupon holly, agarita, deciduous holly, Texas persimmon, mesquite, prickly pear, pencil cactus, pink thoroughwort, Virginia wild rye, slimleaf panicgrass, and wild oat.

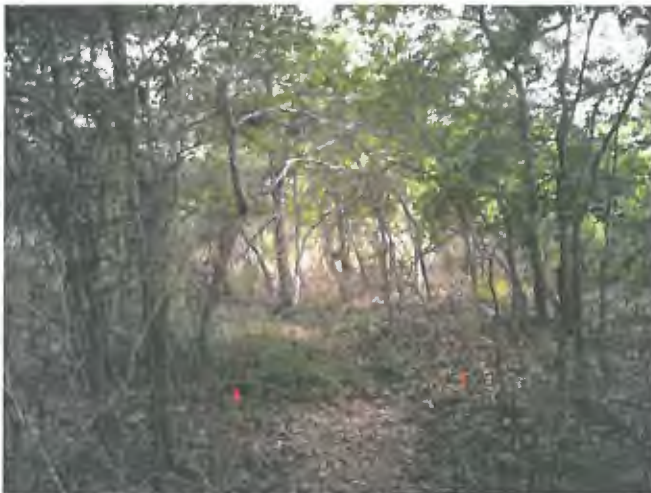
### **Riparian Woods (Cedar Elm/ Oak)**

– This community occurred along riparian corridors at higher elevations and in the upper reaches of ephemeral streams. Dominant vegetation included cedar elm, live oak, post oak, hackberry, giant ragweed, Virginia wild rye, Texas wintergrass, pink thoroughwort, itchgrass, and lean flatsedge.

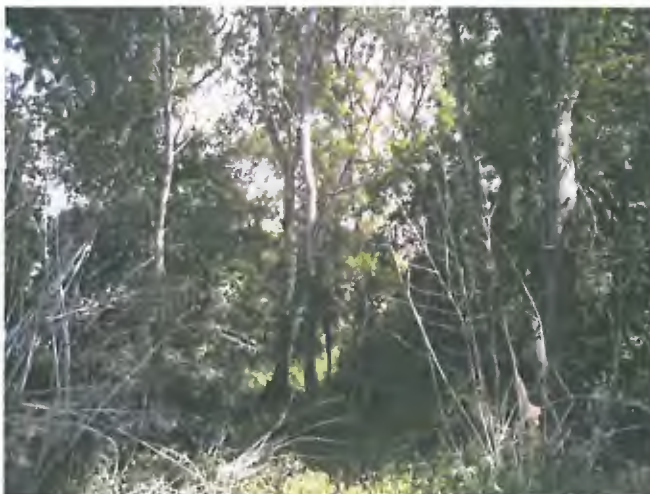
### **Riparian Woods (Green Ash/ Pecan/ Hackberry)**

This community occurred at lower elevations along the larger tributaries within the study area. Dominant vegetation included hackberry, green ash, pecan, Virginia wild rye, giant ragweed, and common greenbriar.

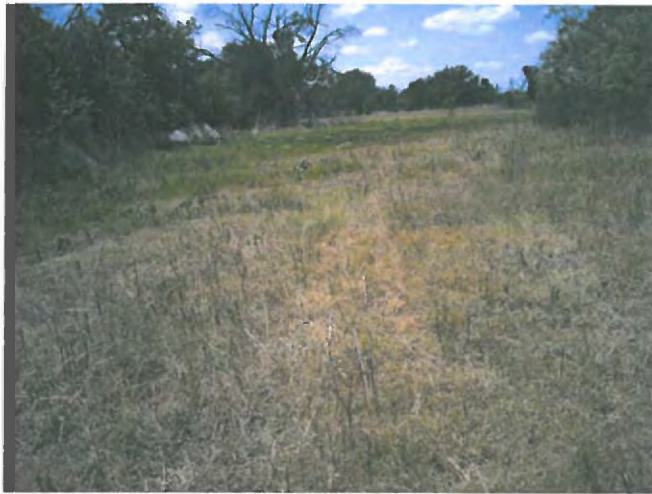
### **Floodplain Meadows**

This vegetation complex occurred within the floodplain of Dry Creek, and appeared to be regularly mowed. Woody vegetation was sparse and limited to scattered cedar elm and bois d'arc. Dominant herbaceous vegetation included common ragweed, giant ragweed, ironweed, shortbeak sedge, rough cocklebur, annual canarygrass, bermudagrass, buffalograss, Virginia wild rye, and Carolina canarygrass.

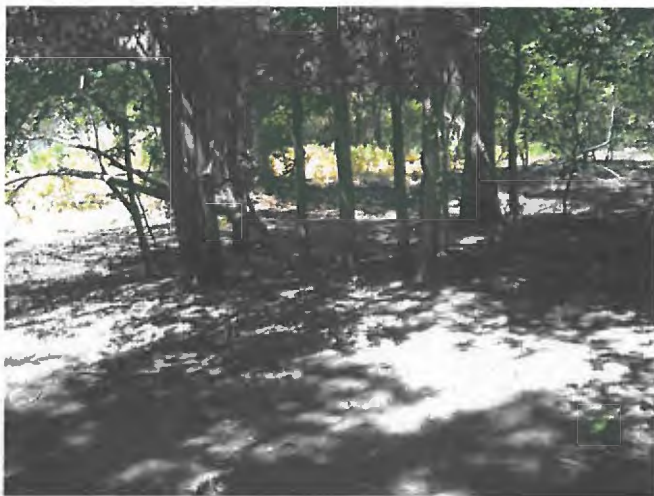
**Forested Wetlands** – This community was observed at lower elevations within the study area. Herbaceous vegetation was more-or-less absent from this community and dominant woody species included green ash and cedar elm.

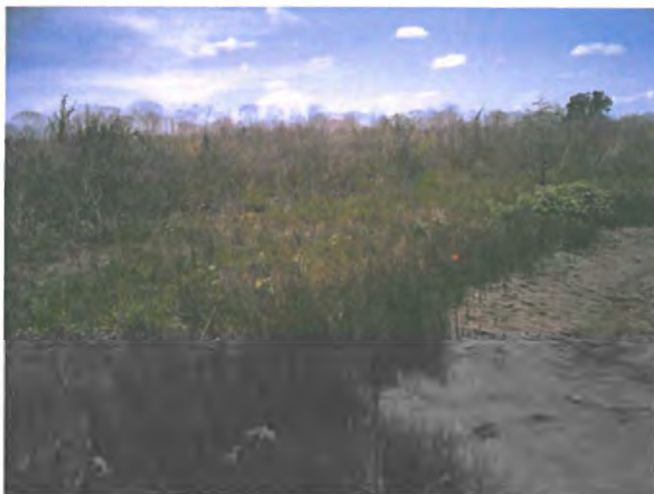
**Emergent Wetlands (Pond Fringe)** - This community occurred along the fringe of stock ponds and was typically surrounded by upland vegetation. Woody vegetation was more-or-less absent from this community with the exception of sesbania and the occasional mesquite or cedar elm at the wetland/ upland transition. Dominant herbaceous vegetation included common spikerush, flatstemmed spikerush, sumpweed, water-pepper, and manyspike flatsedge.

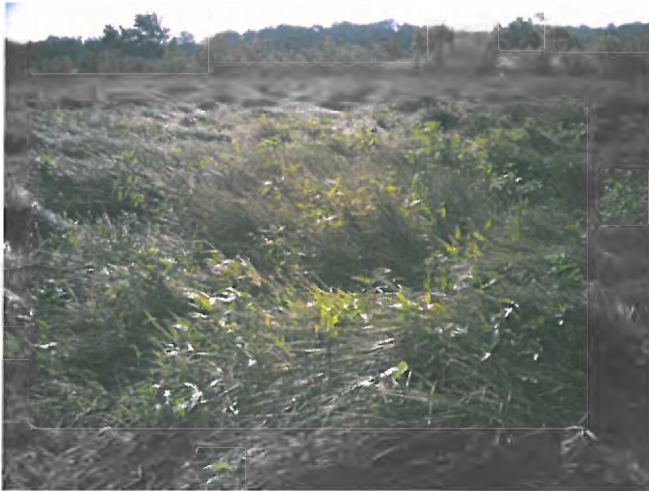
**Emergent Wetlands (Lacustrine Fringe)** – These wetlands occurred along the shoreline and floodplain area of the large lake in the southern portion of the study area. Typical dominant vegetation included several species of spikerush, Pennsylvania smartweed, rough cocklebur, broadleaf arrowhead, and upright burhead.

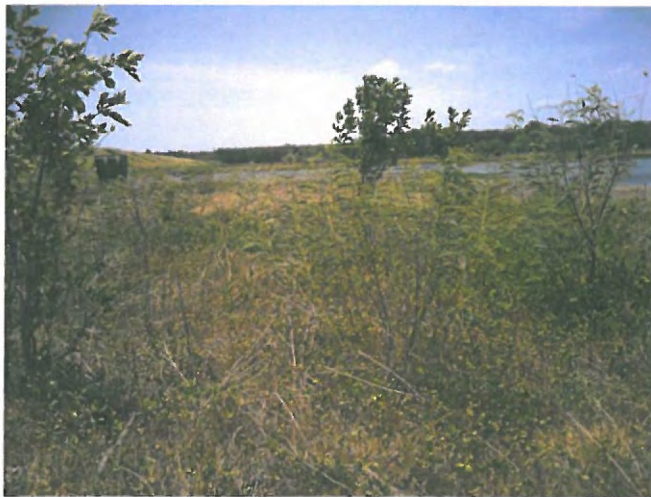
**Scrub/Shrub Wetlands** – These wetlands occurred at higher elevations along the shoreline of the large lake in the southern portion of the study area. Typical dominant vegetation included sesbania, cedar elm, green ash, common spikerush, and sumpweed.
