**130 ENVIRONMENTAL PARK**  
**APPENDIX IIF**  
**CULTURAL RESOURCES SURVEY**

## **CULTURAL RESOURCES SURVEY OF THE 130 ENVIRONMENTAL PARK TRACT CALDWELL COUNTY, TEXAS**

Cultural Resources Report 2013-43  
August 30, 2013

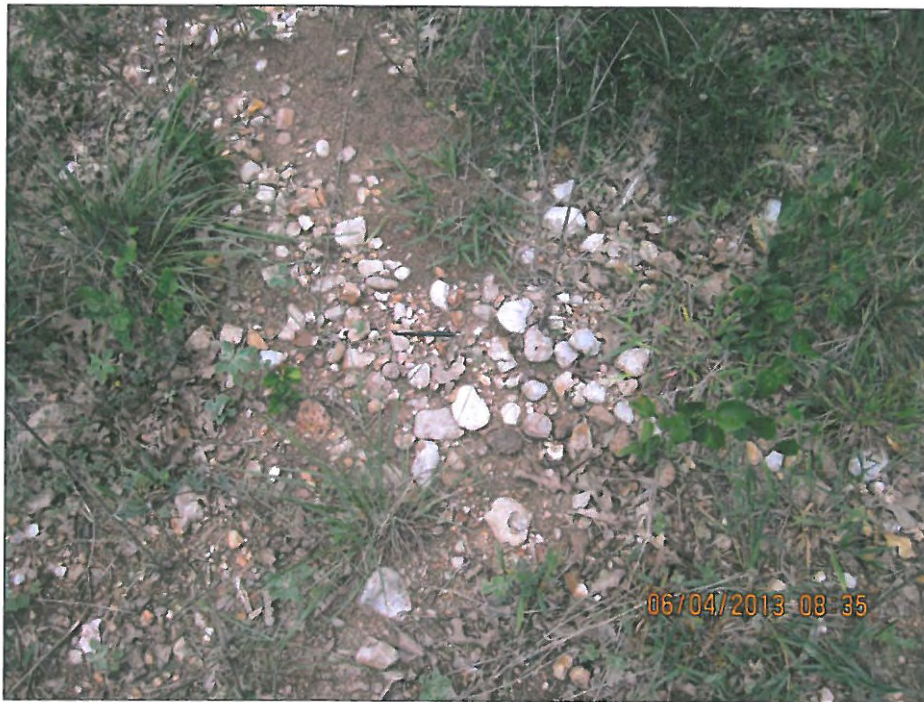
Figure 10. Close-up of chert cobbles on eroded ground surface west of the transmission corridor. The black pen in the center of the picture provides a scale.

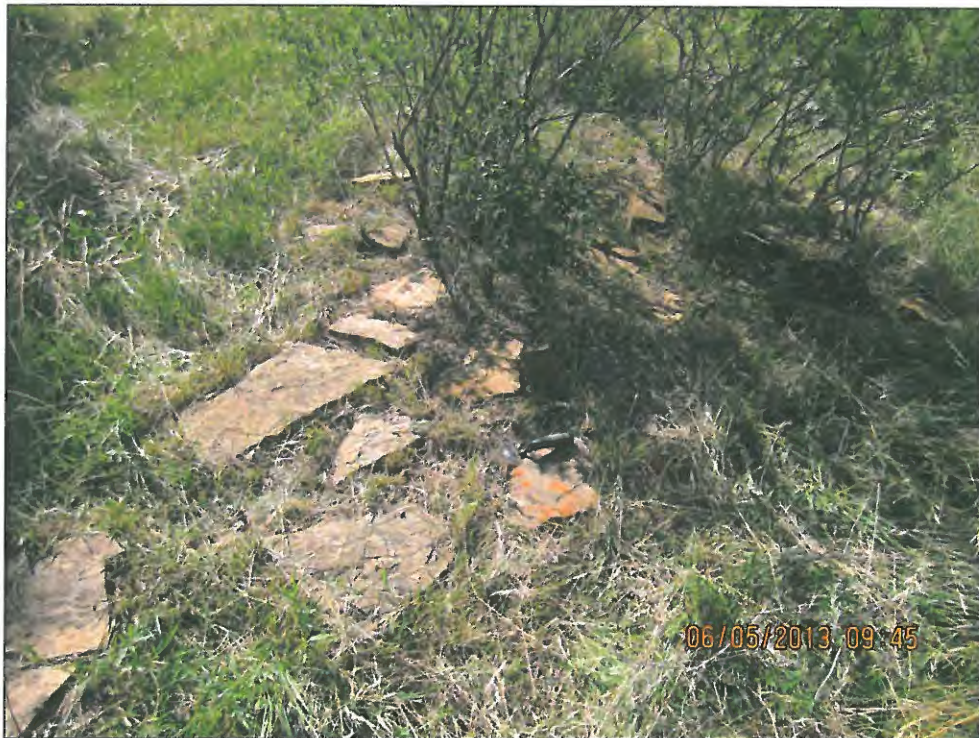
Also identified during the survey were several push or scrap piles of wood and metal, but the materials all appeared to be from the mid-1900s and there were no diagnostic artifacts. These piles most likely represent the razing of fences and pens prior to farming of the various fields. A concentration of thirty sandstone slabs was found in a roadway south of the seed-shaped stock tank previously mentioned. The slabs range in size from 24 by 12 in to 8 by 9 in and have a thickness range of 3.5 to 5.5 in (Figure 11). They are lying flat in an area 12.5 ft (north-northwest/south-southeast) by 6 ft but do not form a recognizable pattern. No historic artifacts were found associated with the slabs and the clay soil contained small cobbles.

Figure 11. Sandstone slabs concentrated in a bulldozed road south of the seed-shaped stock tank. View is to the southeast.

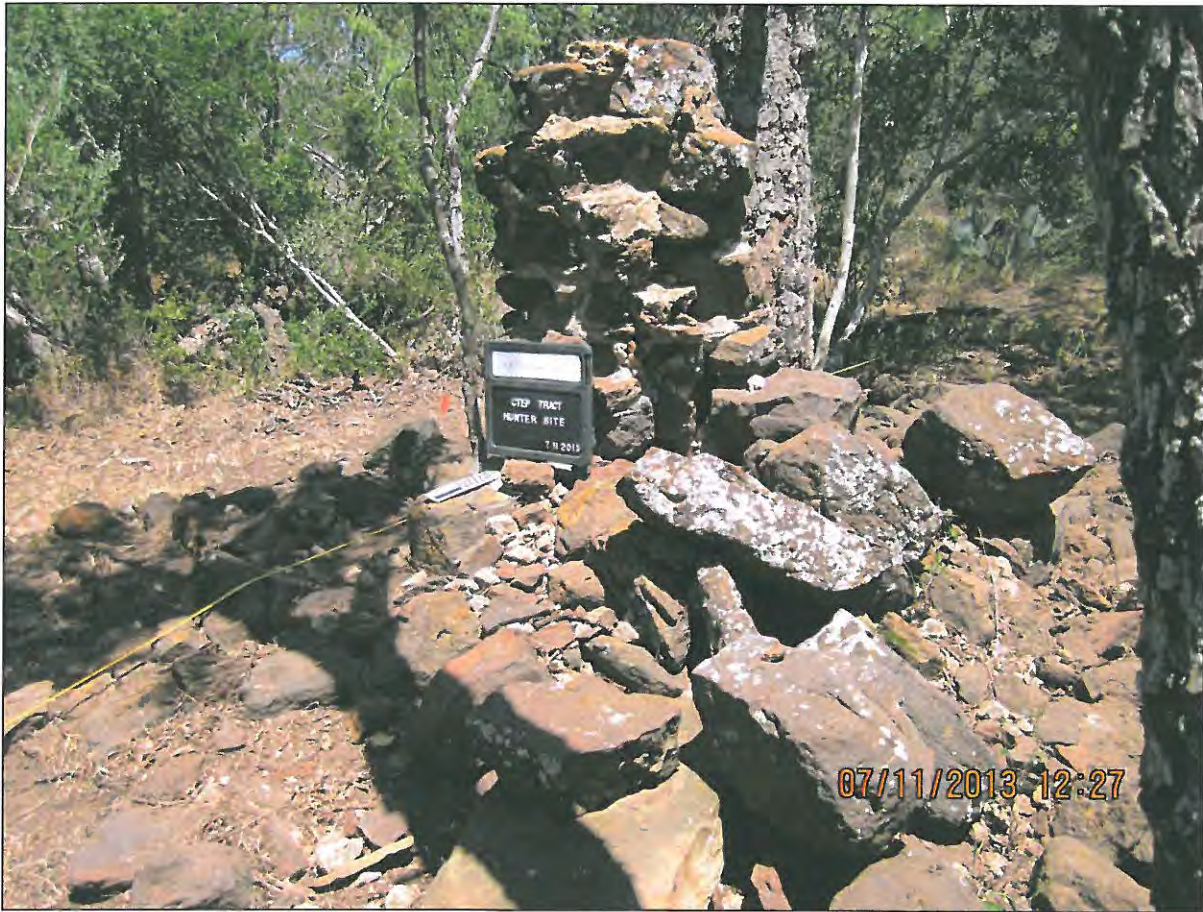
The rock fireplace and chimney have a footprint that is 3 ft deep and 6 ft wide with the opening to the south (Figure 14). The walls and hearth are made of roughly-shaped sandstone blocks that are very dark grayish brown (10YR3/2) in color and contain lighter colored sand. The chimney walls consist of rocks that are mortared together to create a wall that averages 10-11 in thick.

Much of the mortar has eroded away; it only remains between existing rocks of the chimney wall. The chimney stands 43.5 in above the hearth surface and the hearth surface is roughly 12 in above the adjacent ground surface. The chimney fall surrounds the remnant of the standing chimney and covers an area 5 ft to the south, 6 ft to the north, 2 ft to the east, and 2-3 ft to the west. Based on this fall area and the size of the rocks, the chimney is estimated to have been 10-12 ft tall. The rocks that make up the chimney are not present naturally in the immediate area but were quarried and shaped to be used for this purpose.

Figure 13. The rock chimney prior to excavation, looking northwest.

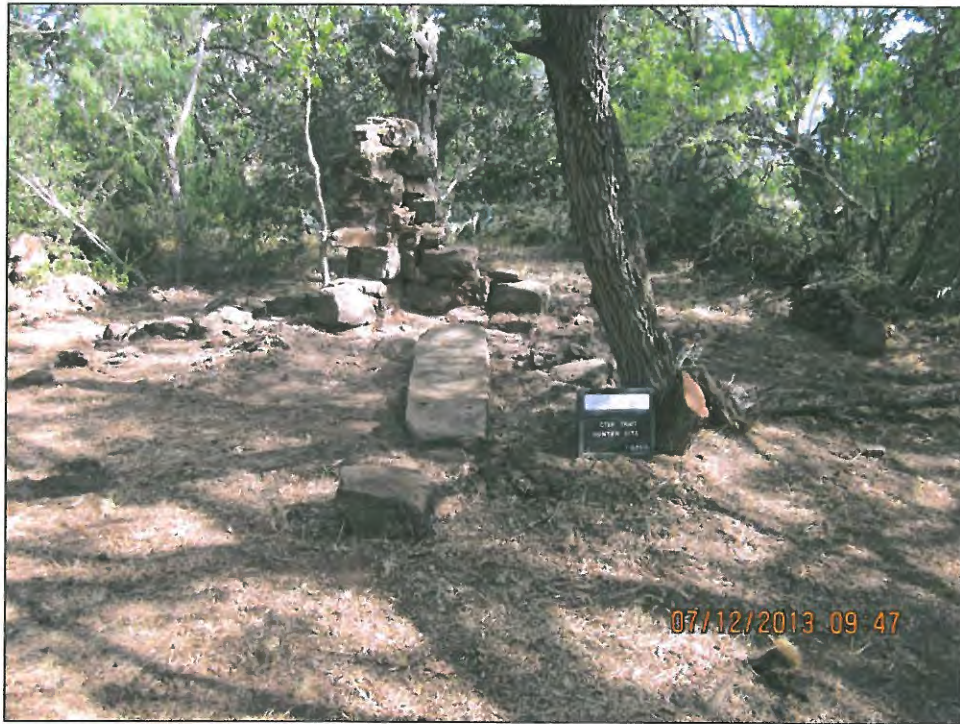
The interesting feature of the chimney fall is a thick sandstone slab that was likely a hearth stone. The slab is 53 in long, 16 in wide, and 6 in thick and could not have been lifted into place by a single person. The sandstone is thinly laminated, well cemented, and is light yellowish brown (10YR6/4) in color. This appears to be an unusual feature as Jordan (1978) does not mention the incorporation of slab hearths in log cabin chimneys.

Figure 15. The Hunter site (41CW159), facing north. Note the large, sandstone slab in front of the chimney.

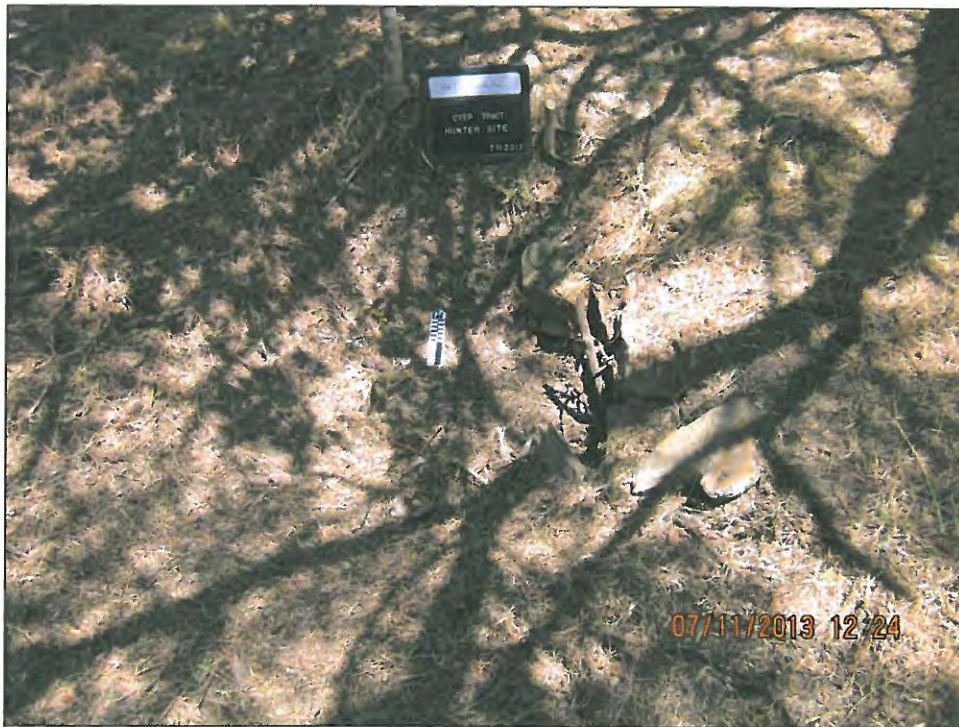
The northeast side of a cistern collar is preserved in the wall of a 3-foot-deep hole located 25 feet southeast of the hearth base (Figure 15). The cistern has an interior diameter of 30-36 in. No mortar was noted between the light yellowish brown sandstone blocks that make up the rock-lining, nor was any mortar apparent on the inner surface of the remaining wall section. Rock,

soil, and metal trash had been used to fill the probably bell-shaped cistern, but no excavation or probing was done in the cistern fill.

Figure 16. The northeast side of the stone-lined cistern collar is in place below the level of the present ground surface. The remainder of the lining and probably the above ground rock collar has probably fallen into the cistern vault.
