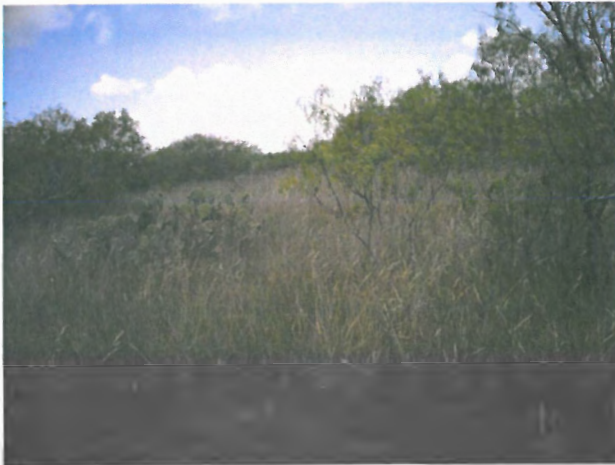
Mesquite Grassland Mosaic

This was one of the most frequently encountered vegetation communities within the study area. Dominant vegetation included mesquite scrub, prickly pear, pencil cactus, Texas persimmon, agarita, Texas wintergrass, lemon bee balm, and plains coreopsis.

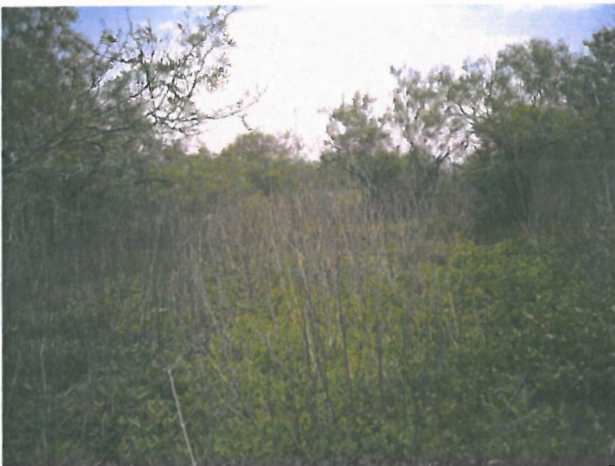
Sumpweed Depression Wetlands

Dominant vegetation in this community included sumpweed and common spikerush. These depressions were emergent wetlands occurring in terraced areas of the surrounding uplands and typically occurred within the mesquite grassland mosaic.

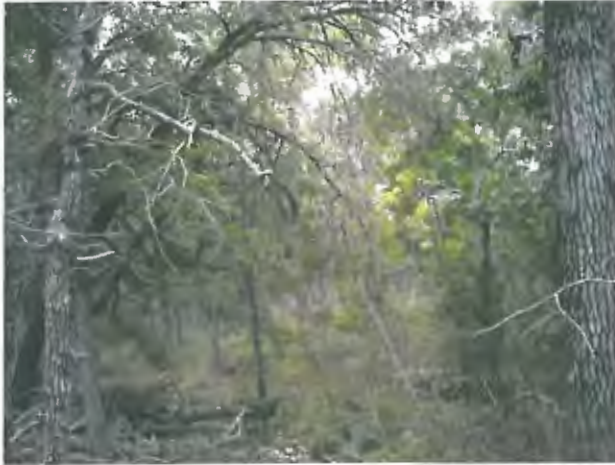
Post Oak/ Cedar Elm Woods

Dominant vegetation in this community included post oak, cedar elm, yaupon holly, agarita, deciduous holly, Texas persimmon, mesquite, prickly pear, pencil cactus, pink thoroughwort, Virginia wild rye, slimleaf panicgrass, and wild oat.

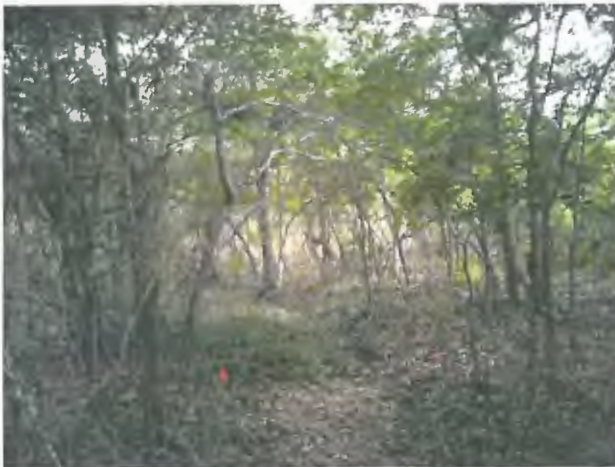
Riparian Woods (Cedar Elm/ Oak) – This community occurred along riparian corridors at higher elevations and in the upper reaches of ephemeral streams. Dominant vegetation included cedar elm, live oak, post oak, hackberry, giant ragweed, Virginia wild rye, Texas wintergrass, pink thoroughwort, itchgrass, and lean flatsedge.

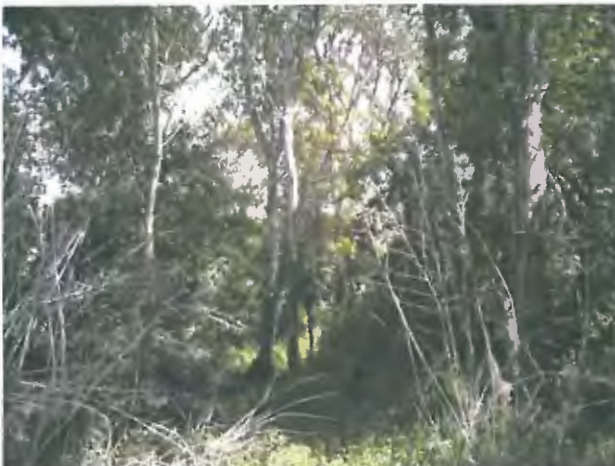
Riparian Woods (Green Ash/ Pecan/ Hackberry)

This community occurred at lower elevations along the larger tributaries within the study area. Dominant vegetation included hackberry, green ash, pecan, Virginia wild rye, giant ragweed, and common greenbriar.

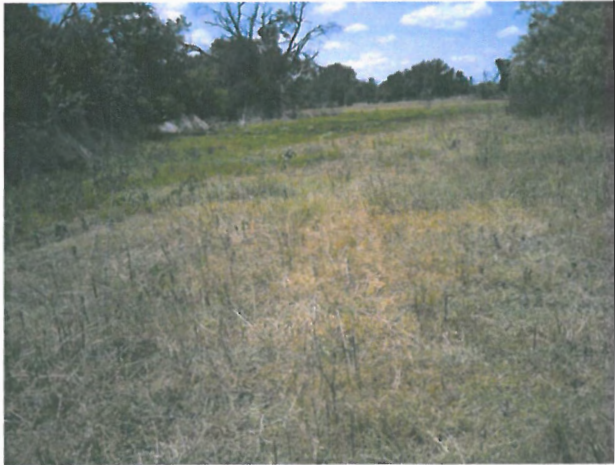
Floodplain Meadows

This vegetation complex occurred within the floodplain of Dry Creek, and appeared to be regularly mowed. Woody vegetation was sparse and limited to scattered cedar elm and bois d'arc. Dominant herbaceous vegetation included common ragweed, giant ragweed, ironweed, shortbeak sedge, rough cocklebur, annual canarygrass, bermudagrass, buffalograss, Virginia wild rye, and Carolina canarygrass.

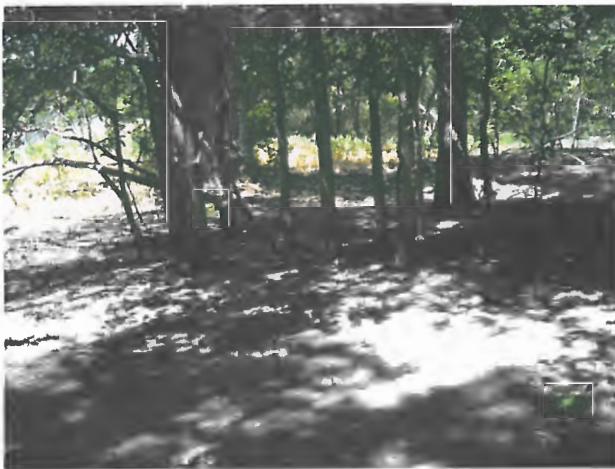
Forested Wetlands – This community was observed at lower elevations within the study area. Herbaceous vegetation was more-or-less absent from this community and dominant woody species included green ash and cedar elm.

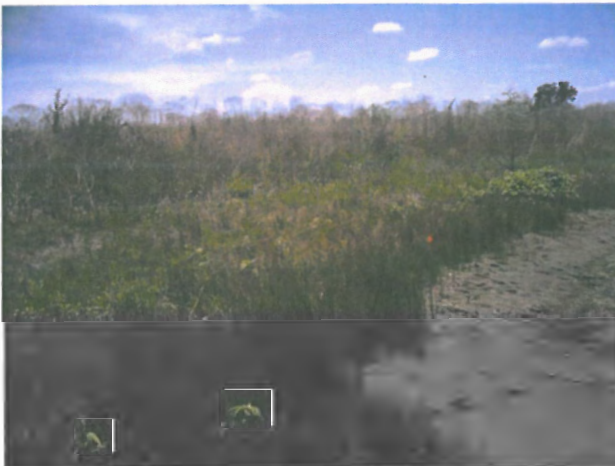
Emergent Wetlands (Pond Fringe) - This community occurred along the fringe of stock ponds and was typically surrounded by upland vegetation. Woody vegetation was more-or-less absent from this community with the exception of sesbania and the occasional mesquite or cedar elm at the wetland/ upland transition. Dominant herbaceous vegetation included common spikerush, flatstemmed spikerush, sumpweed, water-pepper, and manyspike flatsedge.

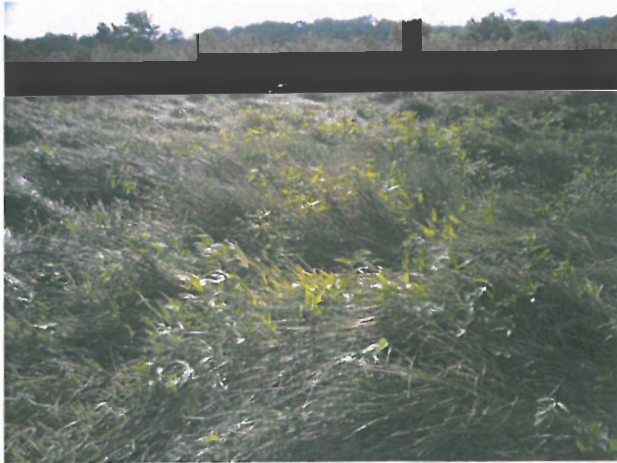
Emergent Wetlands (Lacustrine Fringe) – These wetlands occurred along the shoreline and floodplain area of the large lake in the southern portion of the study area. Typical dominant vegetation included several species of spikerush, Pennsylvania smartweed, rough cocklebur, broadleaf arrowhead, and upright burhead.

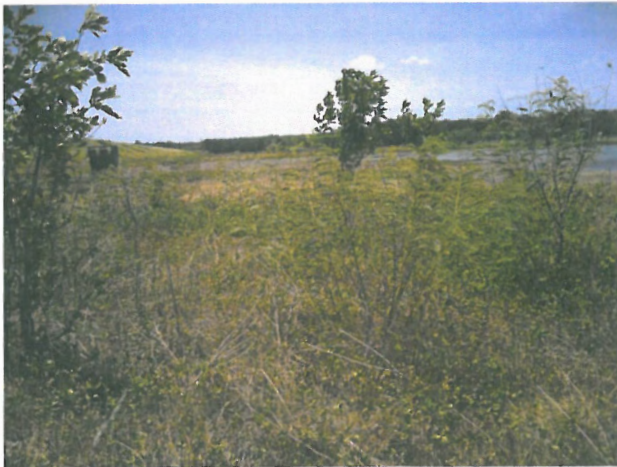
Scrub/Shrub Wetlands – These wetlands occurred at higher elevations along the shoreline of the large lake in the southern portion of the study area. Typical dominant vegetation included sesbania, cedar elm, green ash, common spikerush, and sumpweed.

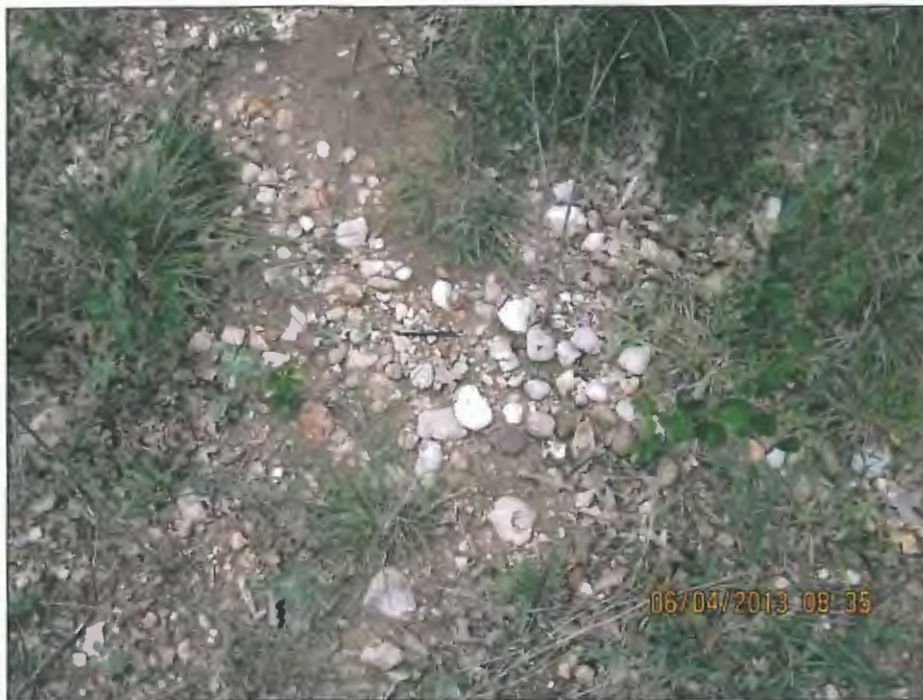
Figure 10. Close-up of chert cobbles on eroded ground surface west of the transmission corridor. The black pen in the center of the picture provides a scale.

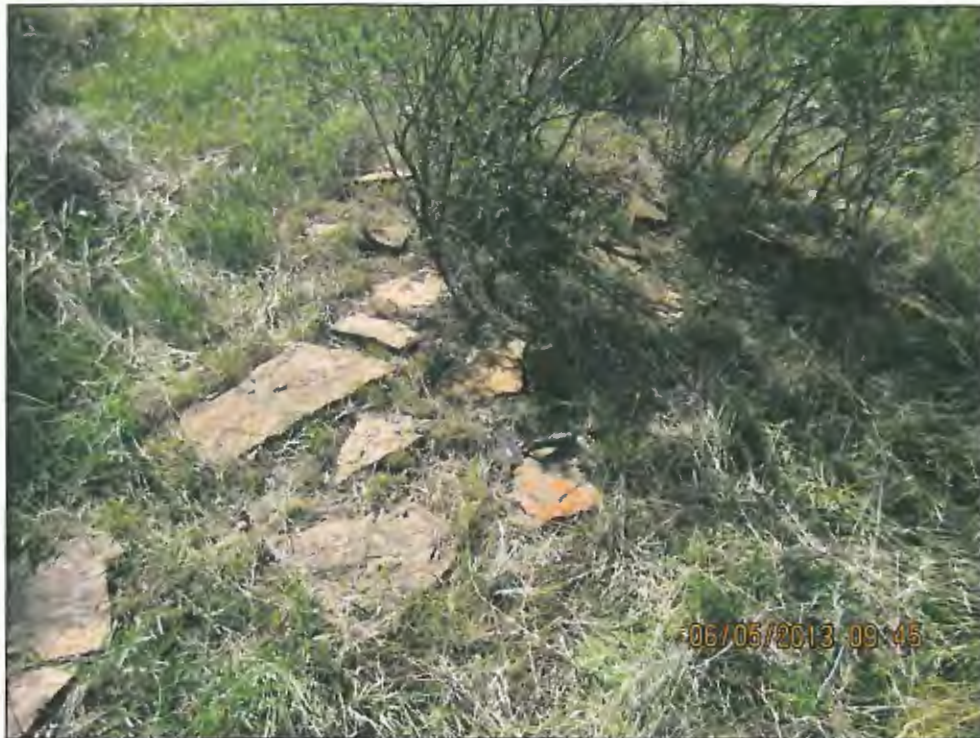
Figure 11. Sandstone slabs concentrated in a bulldozed road south of the seed-shaped stock tank. View is to the southeast.

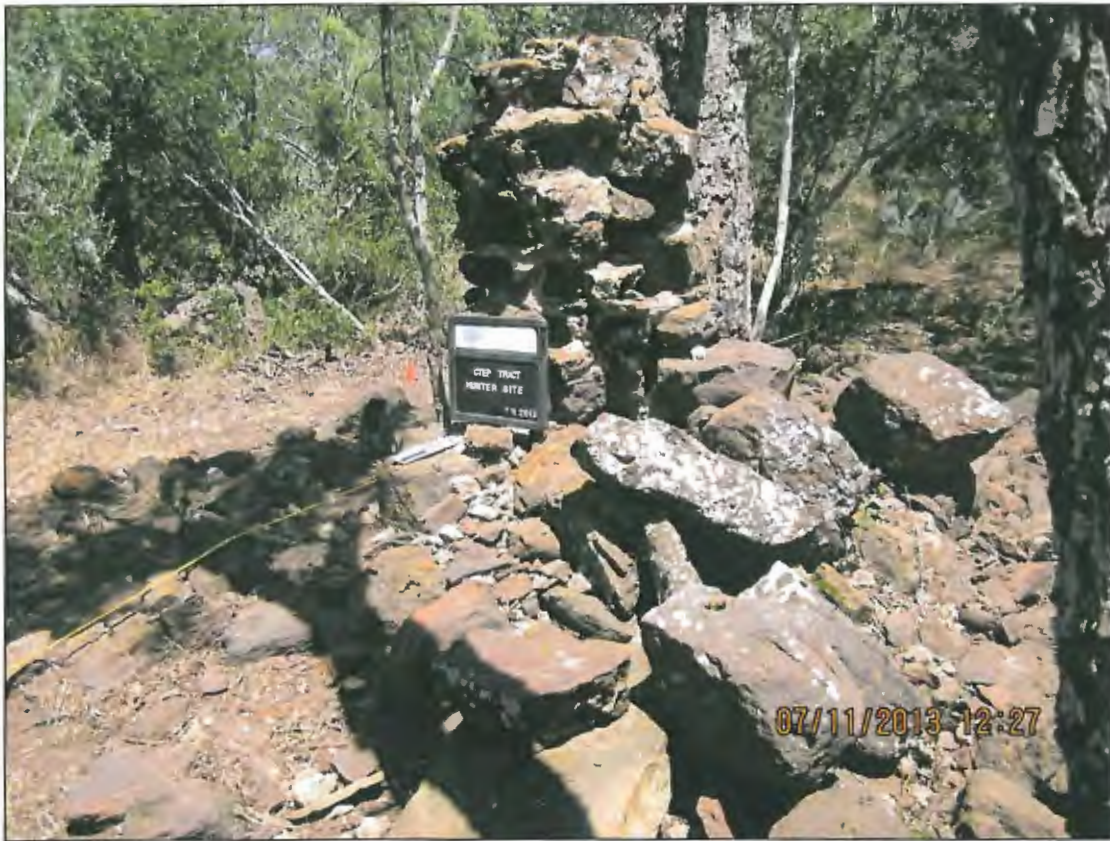
Figure 13. The rock chimney prior to excavation, looking northwest.

The Hunter Site consists of a rock chimney, associated rock fall, rock-lined cistern, and trash scatter. The predominant feature at the site is a partially collapsed stone chimney and associated rubble. The rocks that make up this feature are roughly shaped, dark brown sandstone blocks (Figure 13). The remaining portion of the chimney includes mortared sandstone blocks and smaller chinking rocks and extends vertically out of the pile 4.5 feet. This pillar was the northwest corner of the stone chimney. Several sandstone rocks may represent piers on which the foundation of a log cabin could have been placed. Furthermore, a large rectangular sandstone slab located at the mouth of the fireplace was likely a hearth stone. No wooden superstructure was observed associated with the rocks and an apparent cistern depression was noted near the estimated southeast corner of the one room structure. A thin scatter of historic artifacts was noted on the surface 10 to 15 feet from the structure in all directions. Un-faced commercially made bricks (Figure 14) were the most common artifacts found on the surface, but undecorated clear glass was common, as well. All surface artifacts were mapped in place and collected for analysis.

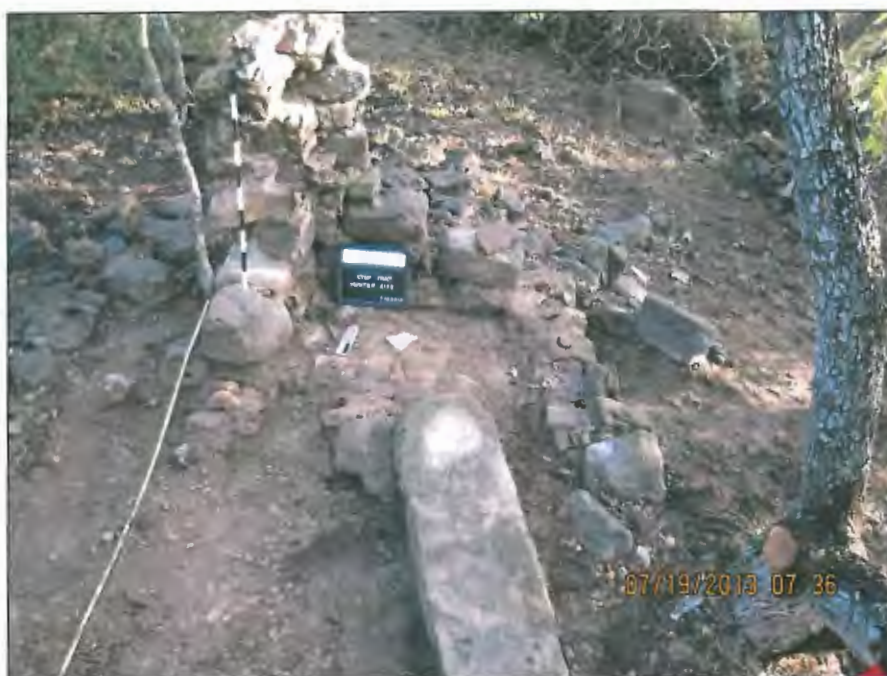
Figure 15. The stone chimney, hearth stone, and partially excavated test units at 41CW157, facing north.

Hand-dug test units were placed outside the east and west walls of the chimney. The unit along the west wall measured 33 in north/south by 19 in east/west. The unit along the east wall measured 32 in north/south by 16 in east west. Two units were excavated inside the chimney fill in order to recover artifact samples and to describe the collapse process. The western unit within the chimney measured 30 in east/west by 57 in north/south and terminated on the north and west sides at the chimney wall. The eastern unit measured 25 in east/west and 46 in north/south. The edges of this unit correlated with the chimney walls on the north and east sides, while the south side was bound by the large hearth stone. All the units were excavated to 20-25 cm below the present-day ground surface, which is below the lowest course of rocks in the chimney base. Pack rats had collected various pieces of metal, glass, ceramics, animal bones, and other artifacts in their nests. Nests were also found surrounding the hearth stone, but the fill in the chimney floor had little pack rat debris. Chunks of mortar, pieces of chinking rock, and larger rock blocks were found in the areas outside the chimney.

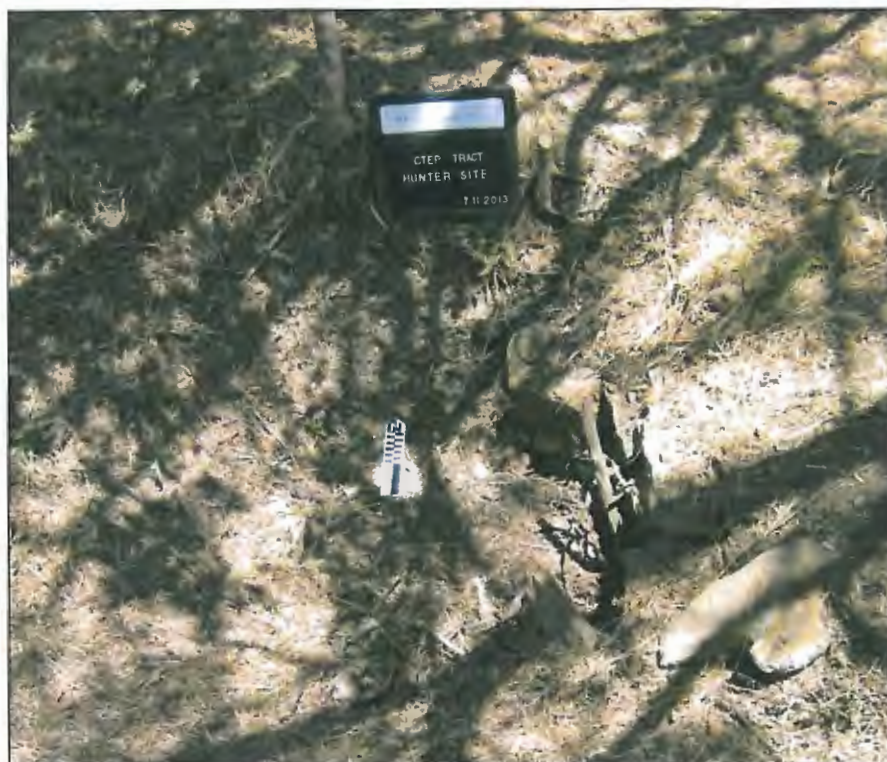
Figure 16. The northeast side of the stone-lined cistern collar is in place below the level of the present ground surface. The fragment of T. V. Allis buckthorn barbed wire is visible entwined with a stick along the east edge of the cistern.

The northeast side of a cistern collar is preserved in the wall of a 3-foot-deep hole located 25 feet southeast of the hearth base (Figure 16). The cistern has an interior diameter of 30-36 in. No mortar was noted between the light yellowish brown sandstone blocks that make up the rock-lining, nor was any mortar apparent on the inner surface of the remaining wall section. Rock, soil, and metal trash had been used to fill the cistern, but no excavation or probing was done in the cistern fill.

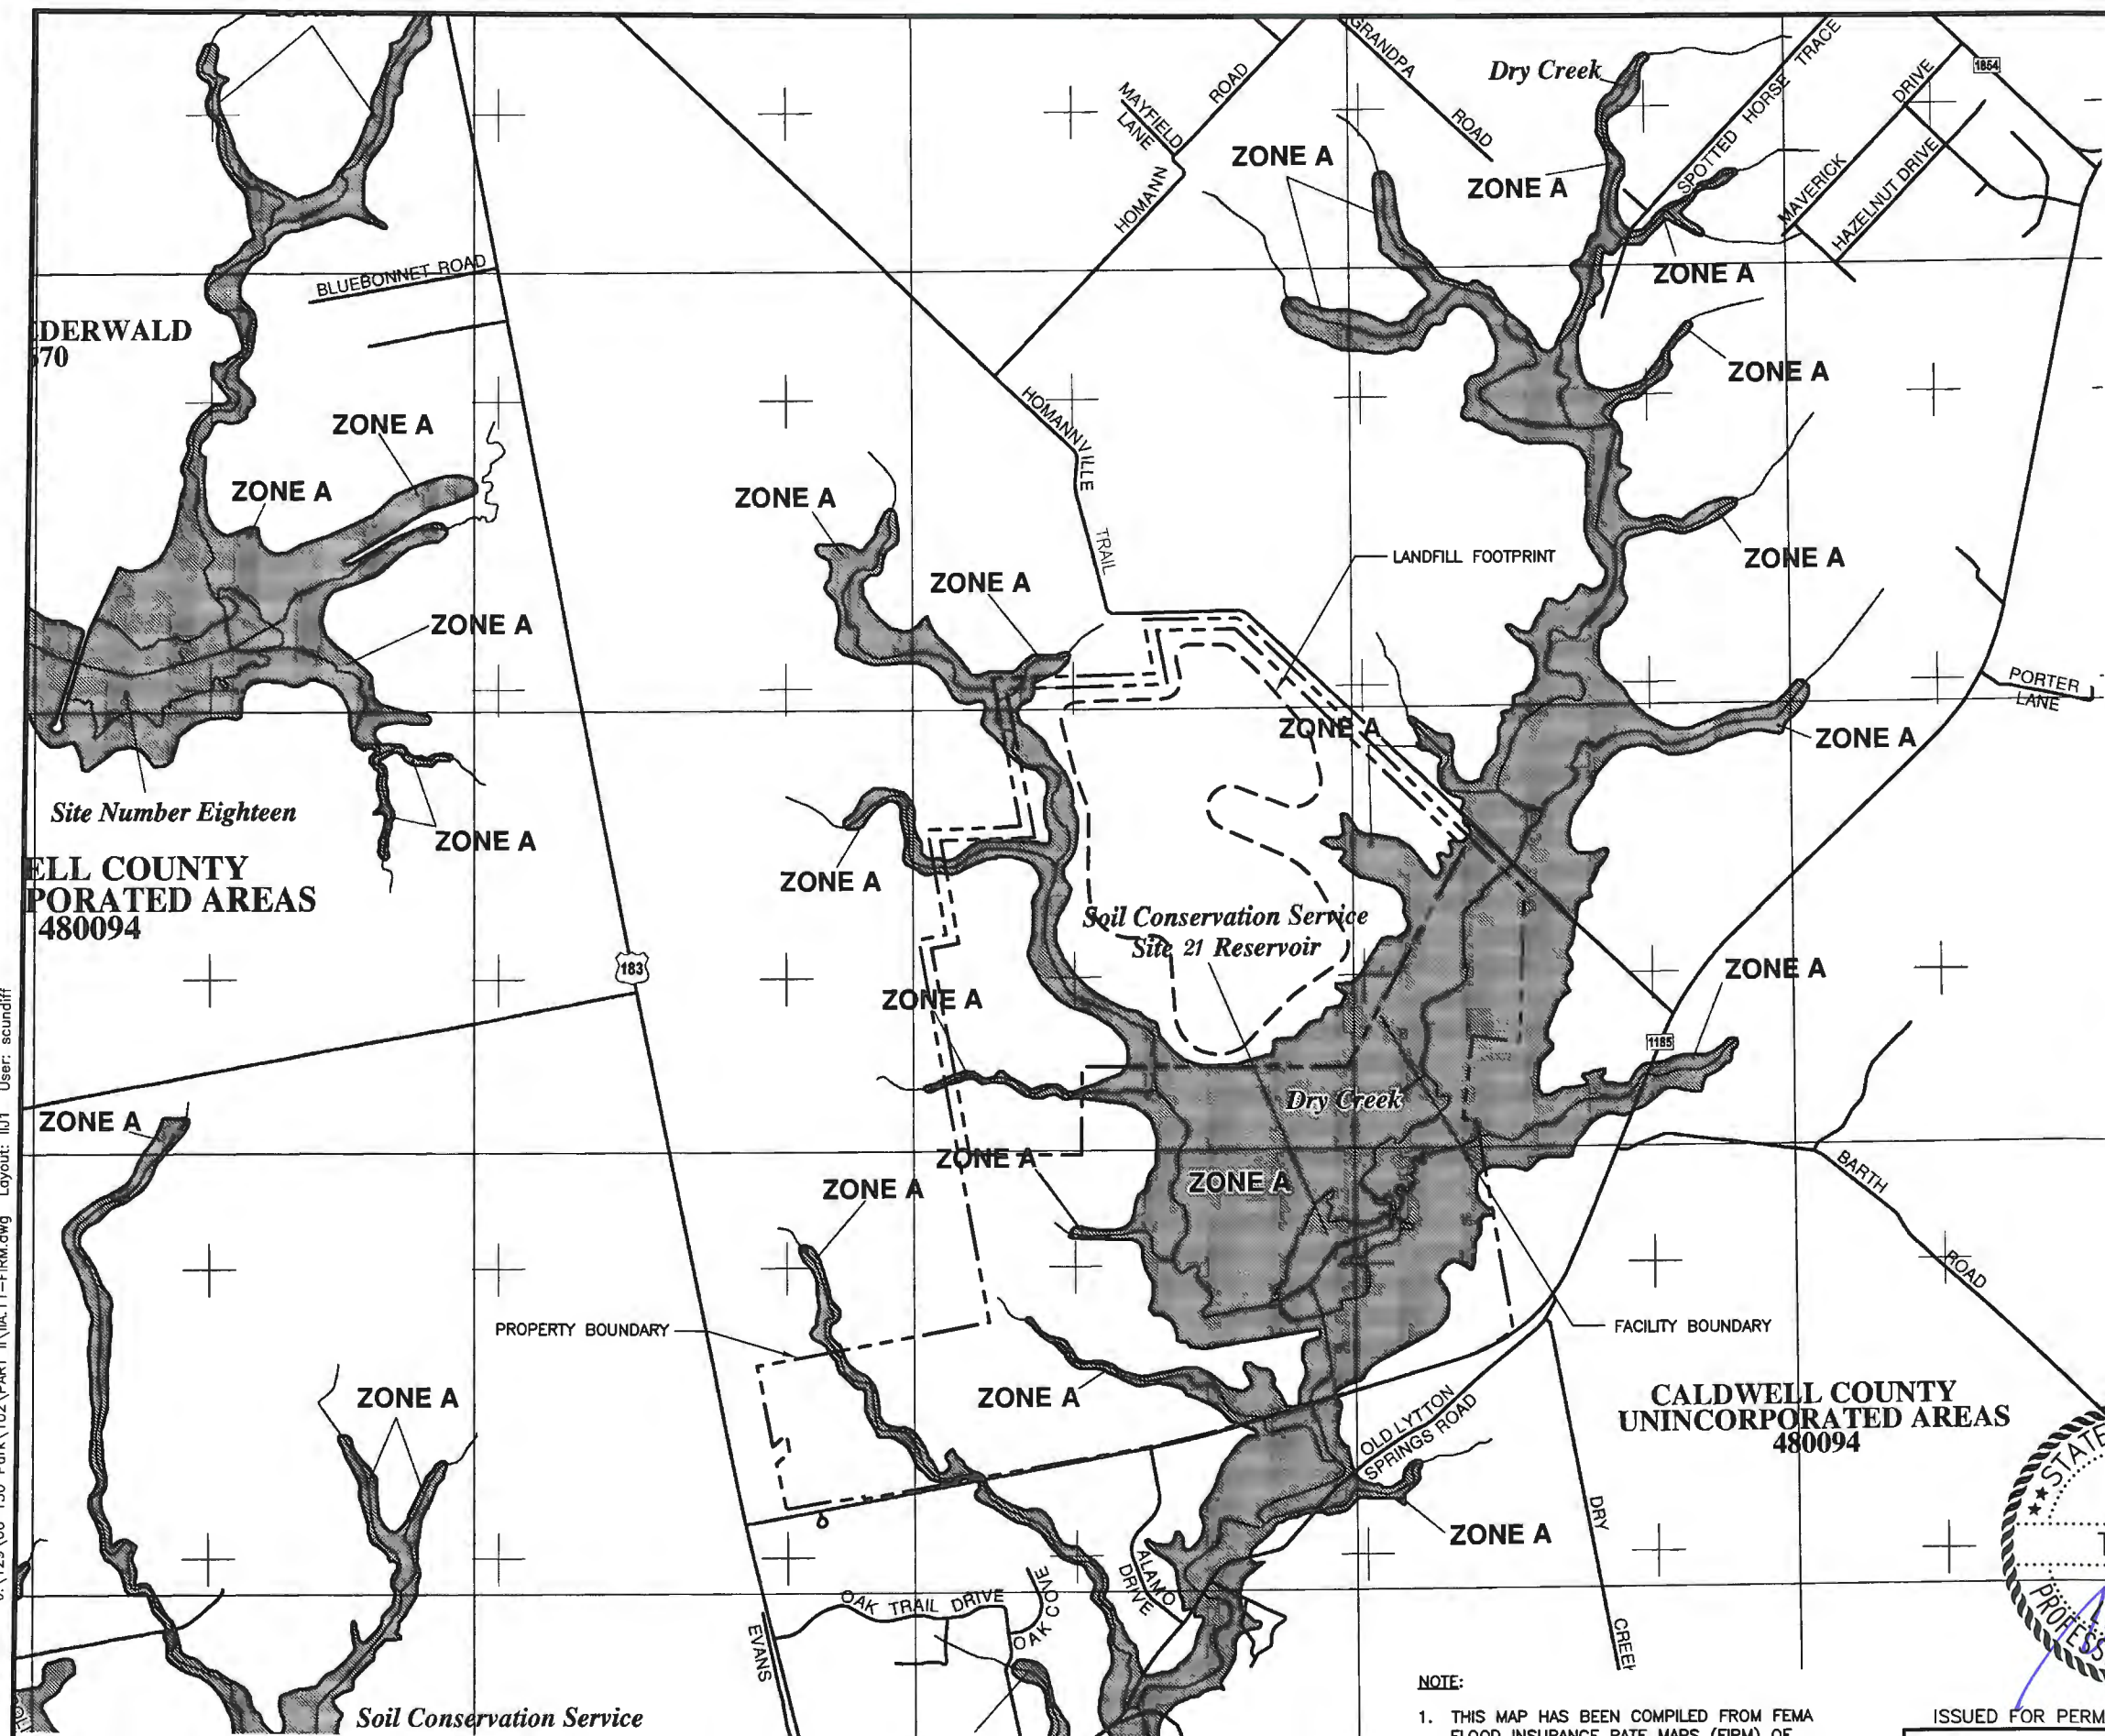
SPECIAL FLOOD HAZARD AREAS (SFHAs) SUBJECT TO INUNDATION BY THE 1% ANNUAL CHANCE FLOOD

NOTE:
1. THIS MAP HAS BEEN COMPILED FROM FEMA FLOOD INSURANCE RATE MAPS (FIRM) OF CALDWELL COUNTY, TEXAS AND UNINCORPORATED AREAS COMMUNITY PANELS:
48055C0125E EFFECTIVE DATE: 6-19-2012
