KETTLEMAN HILLS WASTE LANDFILL SLOPE FAILURE. II: STABILITY ANALYSES

By Raymond B. Seed,¹ Associate Member, ASCE, James K. Mitchell,² Fellow, ASCE, and H. Bolton Seed,³ Honorary Member, ASCE

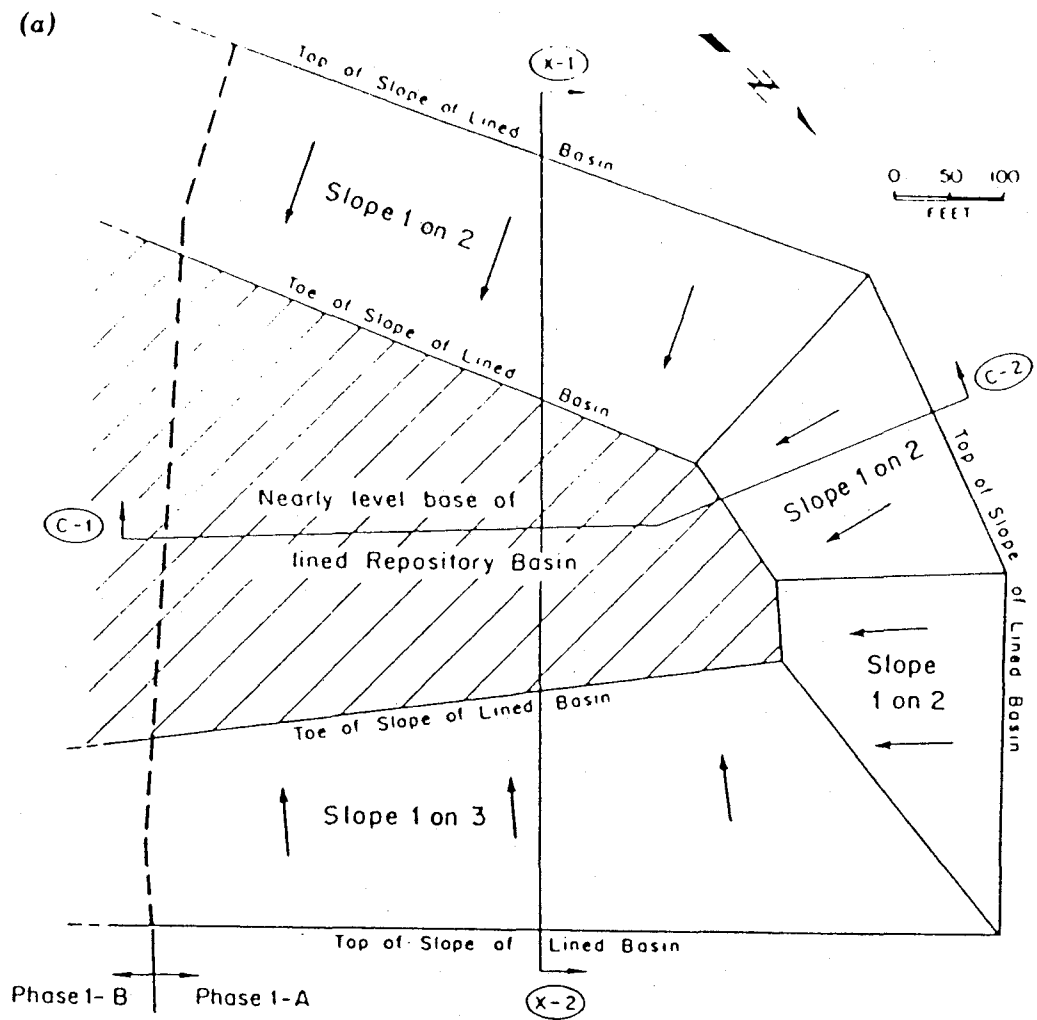
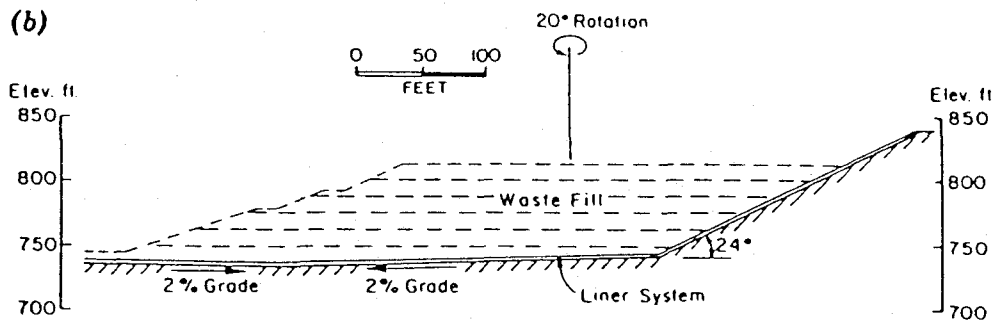
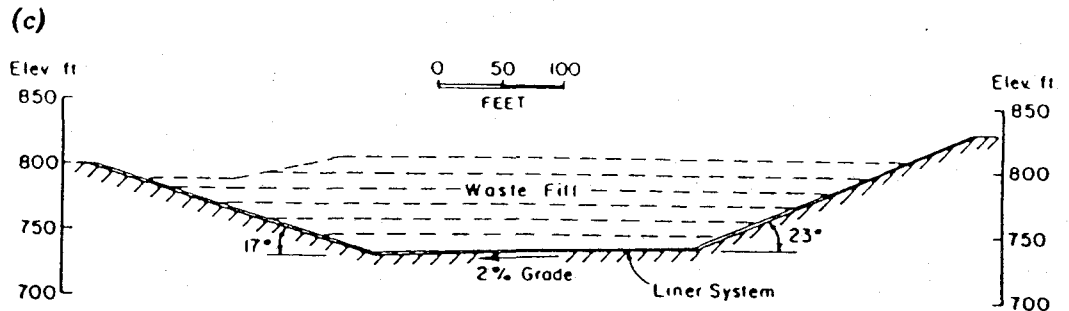
FIG. 1. Landfill B-19, Phase 1-A Cross Sections C-1/C-2 and X-1/X-2: (a) Plan View of Lined Repository Basin; (b) Cross Section C-1/C-2 (Schematic); (c) Cross Section X-1/X-2 (Schematic)

the facility in early 1987. At the same time, the liner systems for other phases of the project were being completed. A plan view of the Phase I-A section of the "bowl" and representative sections showing the configuration of the liner and fill as it existed on March 19, 1988, are shown in Fig. 1.

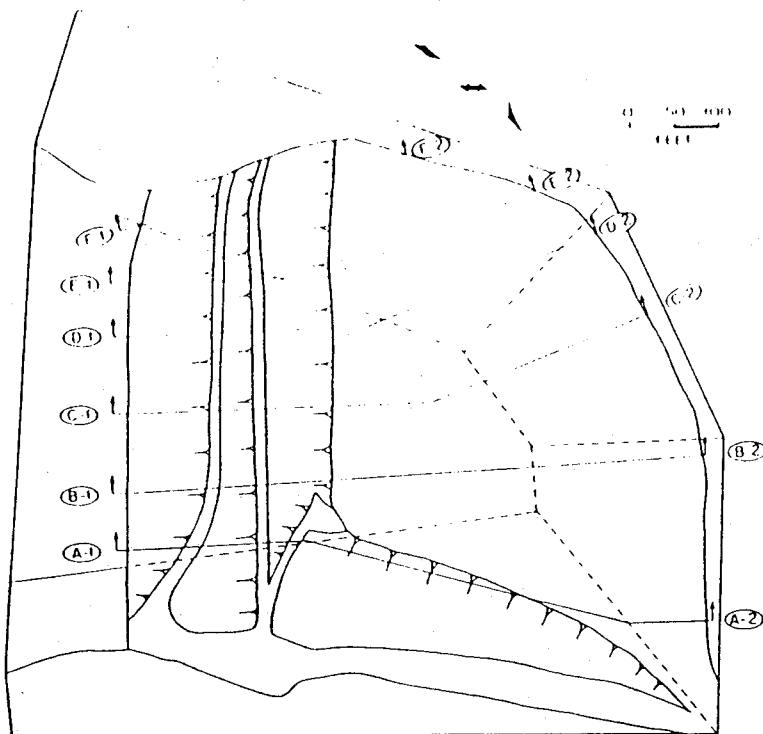
Fig. 5 shows a plan view of the Kettleman Hills Unit B-19, Phase I-A landfill for the conditions existing on March 15, 1988, shortly before the observed slope failure of March 19, 1988. This topography represents a simplification of the more detailed topographical contour map presented in Fig. 3(a).

To understand the mechanisms involved in the observed sliding of March 19, 1988, it is necessary to examine the configuration of the underlying multilayer liner system as well as the surface landfill contours and configuration. Fig. 5 shows the principal preslide surface topography, and also (with dashed lines) the principal grade breaks in the underlying liner system. The Phase I-A landfill represented a partial infilling of a bowl-shaped, lined basin (see Fig. 1). The sides and base of the basin were lined with the multilayer liner system and were thus subject to potential shear slippage in view of the low liner interface-shear strengths.

FIG. 5. Plan View of Landfill Showing Locations of Cross Sections A-1/A-2 through F-1/F-2

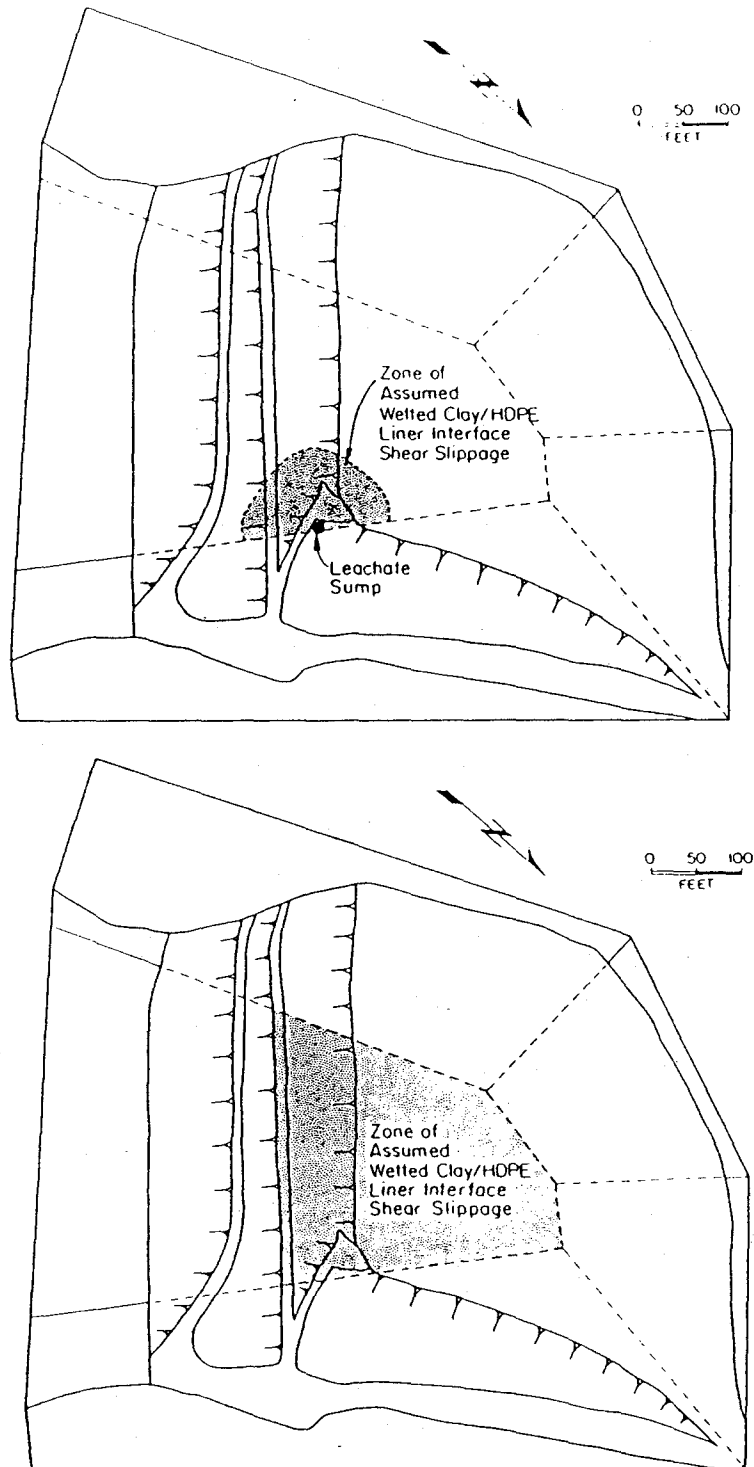
FIG. 6. Plan Views of Landfill Showing Range of Zones of "Base Wetting" Assumed for Analyses: (a) Probable Minimum Clay Liner Wetting Case (b) Full-Base-Wetting Case

It should also be noted that a number of mechanisms can be hypothesized as possibly resulting in "wetting" of the HDPE liner/compacted clay liner interface. These include rainfall during liner placement, squeezing of water from the liner clay itself during consolidation under the fill overburden pressures, and/or wetting associated with water ponding in the vicinity of the leachate collection system sump. As it is not possible to reliably predict the actual extent of HDPE liner/compacted clay liner interface wetting that occurred, all stability analyses were performed for two possible cases. The first of these was a "Probable Minimum Clay Liner Wetting Case" involving wetting of the HDPE liner/compacted clay liner interface only in the vicinity of the leachate-collection sump, as illustrated in Fig. 6(a). The "wetted" zone shown in this figure represents the probable minimum zone of HDPE liner/compacted clay liner interface wetting based on records of leachate-ponding levels in the sump. The "wetted" HDPE liner/compacted clay liner interface-shear strength of $\tau_r = 900$ psf would represent the most critical shear-failure mechanism within this wetted zone only to the north of the second (upper) access road across the southeast face of the waste fill, as the fill depth to the south of this road is less than 58 ft.

The second case analyzed was the "Full-Base-Wetting Case," involving wetting over the full base of the lined waste basin, but not the sloping sides of the basin. This corresponds to the "worst case" or most critical probable conditions. For the Full-Base-Wetting Case, the "wetted" HDPE liner/compacted clay liner interface shear strength of $\tau_r = 900$ psf would again represent the most critical potential shear-failure mechanism only to the north of the second (upper) access road across the southeast face of the waste fill [as shown in Fig. 6(b)], as the fill depth to the south of this road is less than 58 ft.

For the Probable Minimum Clay/Liner Wetting Case, in which “wetting” of the HDPE liner/compacted clay liner interface was assumed to occur only near the leachate sump [as shown in Fig. 6(a)], the shear resistance within the multilayer liner system was taken as $\phi_r = 8.5^\circ$ on the sloping sides of the lined fill basin, and as $\phi_r = 8^\circ$ at the nearly level base of the basin, except in the “wetted” zone near the leachate sump and north of the upper access road on the southeast face of the waste fill. In this localized area, the liner-interface-shear resistance was taken as $\tau_r = 900$ psf.

For the Full-Base-Wetting Case, shear failure was assumed to occur on a "wetted" HDPE liner/compacted clay liner interface with $\tau_r \approx 900$ psf over the full central base of the Unit B-19, Phase I-A landfill, as shown in Fig. 6(b). The shear resistance within the liner system over the remainder of the nearly level base of the fill basin was taken as $\sigma_N \tan \phi_r$, where $\phi_r = 8^\circ$. The shear resistance within the liner system on the sloping sides of the lined fill basin was again taken as $\phi_r = 8.5^\circ$.

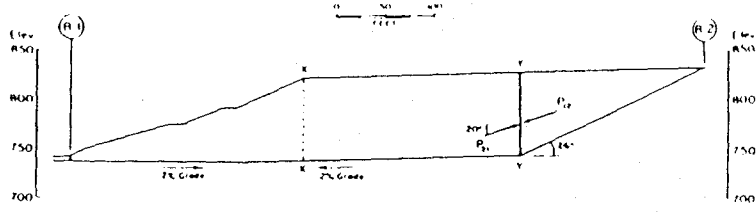
Ten representative cross sections were selected for stability analysis. Six of these sections were located as shown in plan view in Fig. 5. These six cross sections, Sections A-1/A-2 through F-1/F-2, are shown in Fig. 7. The cross sections through the central portions of the landfill (Sections B-1/B-2, C-1/C-2, and D-1/D-2) are characterized by an active wedge or driving block at the northwest end of each cross section [see for example Block #1 in Fig. 7(b)], and a passive resisting block at the southeast end [see for example Block #2 in Fig. 7(b)]. It may be noted that the section of the passive block between sections XX and YY in Figs. 7(b), (c), and (d), becomes significantly smaller in moving from Section B-1/B-2 through C-1/C-2 and D-1/D-2, resulting in progressively decreasing passive resistance to sliding. At the northeast and southwest sides of the landfill, the cross

FIG. 7. Kettleman Hills Unit B-19, Phase 1-A Landfill: (a) Cross Section A-1/A-2; (b) Cross Section B-1/B-2; (c) Cross Section C-1/C-2; (d) Cross Section D-1/D-2; (e) Cross Section E-1/E-2; (f) Cross Section F-1/F-2
